**James Jones**

**123 Second Street  
USA**

May 06, 2020

## General Summary

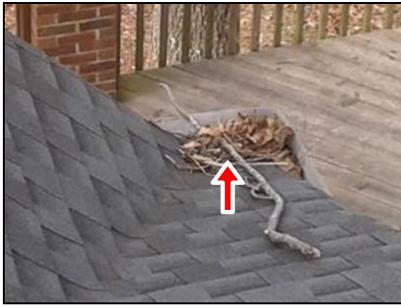
Observed multiple gutters filled with debris, keep clean for proper function. All gutters should be checked for damage, blockage, or overflow on a regular basis (at least twice annually). Gutter guards may help in cases where leaves and other debris routinely accumulate in a short period of time. Condition is conducive to further damages. Evaluation / Correction by a qualified handyman contractor is recommended for this

entire condition.

Debris and gutters

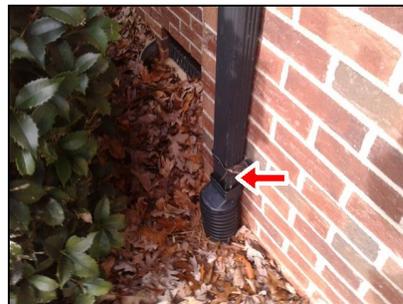
Observed downspouts terminating at the foundation wall and missing diverter / splash block / leader pipes in various locations (See Photos). Providing an adequate roof drainage system, diverting all downspouts away from the foundation and providing adequate soil grading and ground cover at the foundation and throughout the site are primary remedial factors to consider for any water penetration concerns. Downspouts that run into the ground are subject to backup / blockage. Neither the presence nor integrity of underground lines, nor free flow of water through such lines is determinable as part of this inspection. Condition is conducive to water penetrations into crawl space and other areas. Evaluation / Correction by a qualified handyman contractor is recommended for this entire condition.

Underground drain system

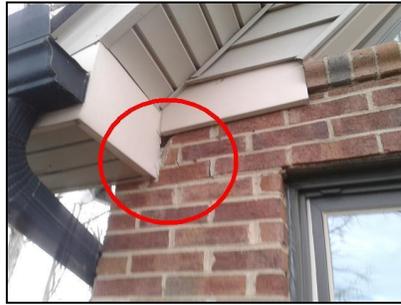
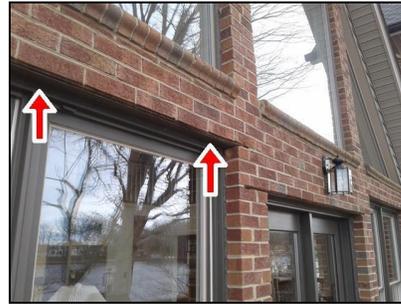
Observed cracking and separation in the brick mortar joints where the brick sits on top of the window lintils at the rear family room wall. This is an indication of some previous movement due to potential water penetrations. (See interior section of this report for further comments) Further / Investigation / Evaluation / Correction by a qualified contractor is recommended for this entire condition.

Rear family room wall

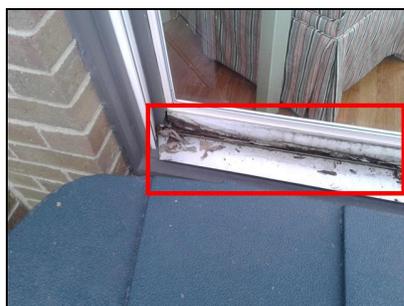
**Observed wood rot / decay / damage and deterioration at multiple window frames around the home. Condition is conducive to further damages. Evaluation / Correction by a qualified general contractor is recommended for this entire condition.**

Rear family room windows

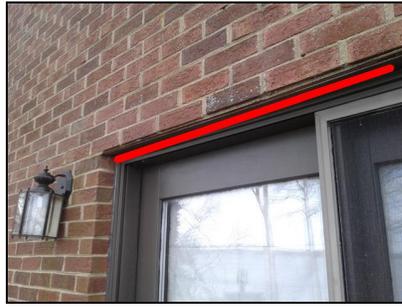
**Observed that all steel lentils over exterior windows and doors need to be rust proof painted. Condition conducive to rusting which in turn will expand the steel and cause mortar joint cracking. Evaluation / Correction by a qualified handyman contractor is recommended for this entire condition.**

All exterior doors

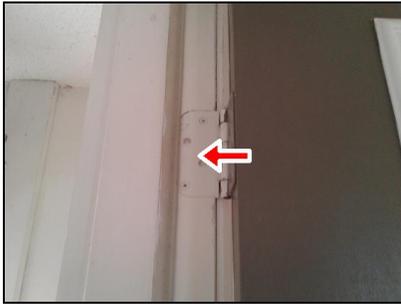
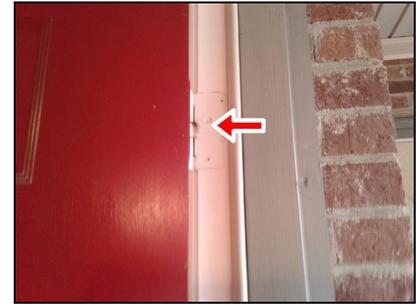
Observed missing hinges screws at several exterior doors (See photos for locations) Condition is conducive to door sagging, rubbing over a period of time. Evaluation / Correction by a qualified handyman contractor is recommended for this entire condition.

Garage / House door

Rear door

Front door

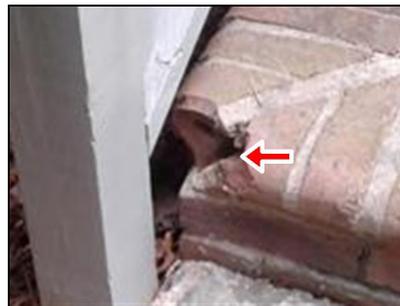
Observed open mortar joints and loose bricks at the front steps in several locations. All open mortar joints need to be sealed to prevent water penetrations. Condition is conducive to further damages. Evaluation / Correction by a qualified handyman contractor is recommended for this entire condition.

Front stairs

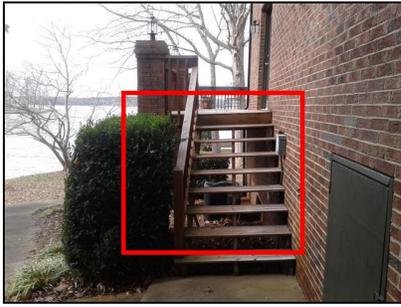
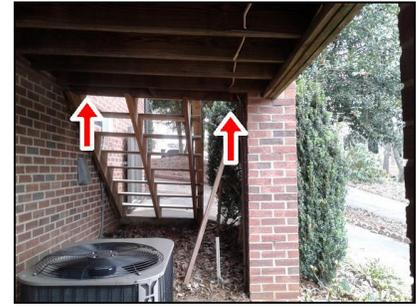
Observed that the left side of the deck and stairs have dropped slightly. The frame has also come loose from the first brick column. It appears that the brick columns itself has settled slightly over a period of time causing this damage. Further / Evaluation / Correction by a qualified general contractor is recommended for this entire condition.

Left side of deck

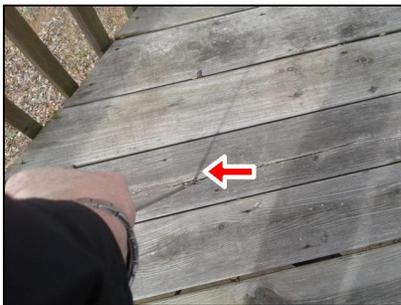
Observed decking and railings to have cracked / deteriorated materials in various areas and some nails are backing out. Repair / replace cracked and deteriorated materials as needed and for weathered deck surfaces we recommend sealing wood as needed and resetting nails. Condition is conducive to further damages. Evaluation / Correction by a qualified general / handyman contractor is recommended for this entire deck / condition.

Main deck surface

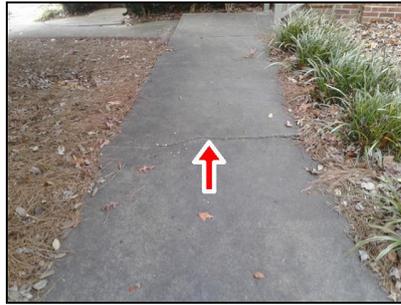
Observed sections of the concrete walkways that are raised up. Although concrete movement and typical cracking is common in almost every home this condition poses a safety (tripping) hazard. Evaluation / Correction by a qualified contractor is recommended for this entire condition.

Front sidewalk

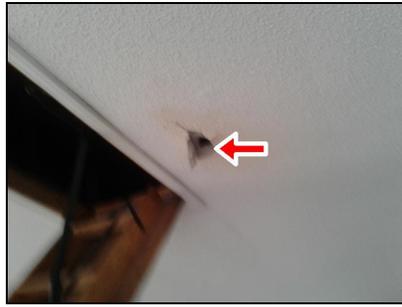
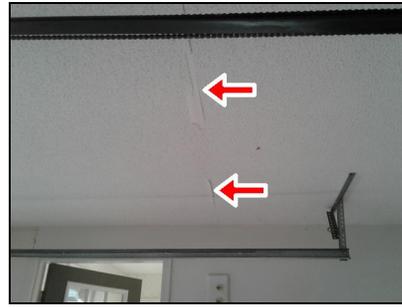
holes must be drywall taped. Evaluation / Correction by a qualified handyman contractor is recommended for this entire condition.

Garage ceiling

Garage ceiling joints

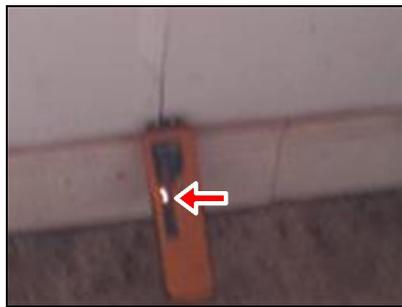
Observed a high moisture content under one of the garage windows along the back wall. Exterior evidence points to a hole in the brick row lock and cracked caulking joints around this window. Condition is conducive to further damages. Evaluation / Correction by a qualified contractor is recommended for this entire condition.

Garage rear wall under window

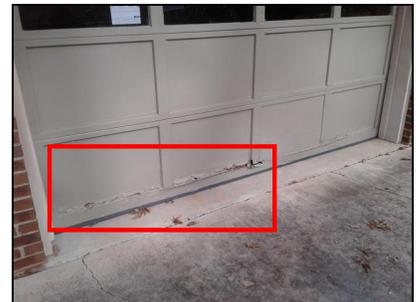
Observed that all three of the garage doors at wood rot / and moisture damages at the bottom panels and other various locations. Condition is conducive to further damages. Evaluation / Correction by a qualified garage door contractor is recommended for this entire condition.

Bottom of garage doors

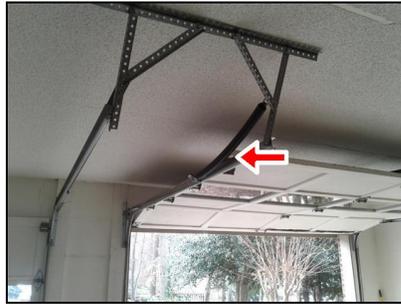
Observed that the garage door that is closest to the house entrance is missing the door springs. Condition is conducive to further damages. Evaluation / Correction by a qualified garage door contractor is recommended for this entire condition.

GD 3 springs

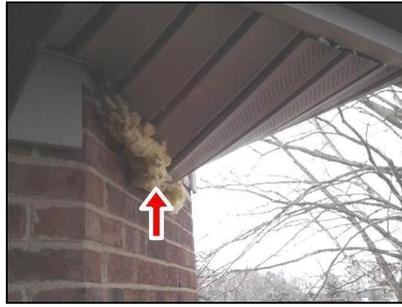
Observed evidence of a large rodent penetration into the upper attic area. The soffit at the upper right overhang has been severely damaged and opened and there is evidence of animal droppings and damaged insulation in multiple locations. Condition is conducive to further damages. Evaluation / Correction by a qualified pest control contractor is recommended for this entire condition.

Rodent nesting

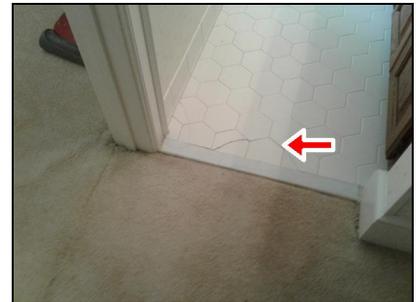
Cracked tile in master bath

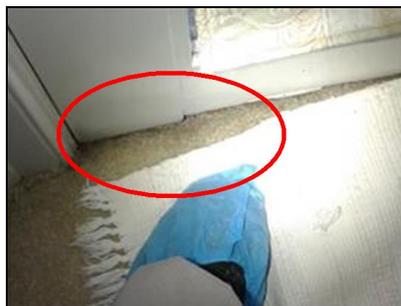
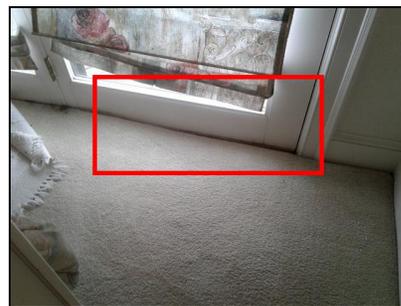
Observed water damages at the master bedroom subflooring at the exterior door. This is due to water penetrations into the door frame and under the sill plate. Condition is conducive to further damages. Evaluation / Correction by a qualified general contractor is recommended for this entire condition.

Master bedroom floor

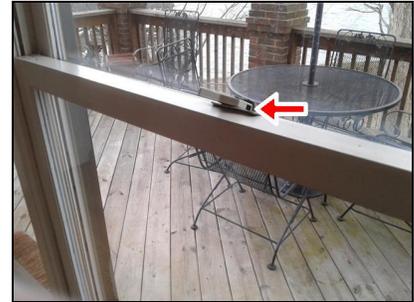
Observed multiple windows throughout the home that do not functioning as intended and are most likely painted shut / have broken spring balances or hardware that is difficult to operate. This condition is a concern in regards to safety conditions and egress in case an emergency exit is needed. (Recommend checking all in all locations). Evaluation / Correction by a qualified general contractor is recommended for this entire condition.

Check all windows

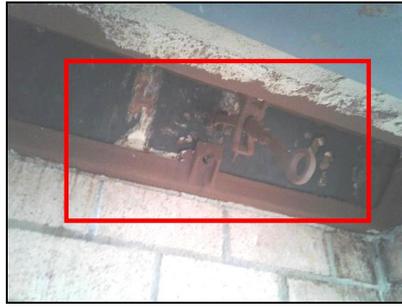
Observed that the fireplace damper door does not have a safety clamp installed. The safety clamp will not allow the damper door to be closed completely. This is a safety concern due too fireplaces having gas logs installed. It was not possible determined if this gas logs were the non-vented type. Condition is conducive to a potential safety hazard. Evaluation / Correction by a qualified fireplace contractor is recommended for this entire condition.

Fireplace damper door

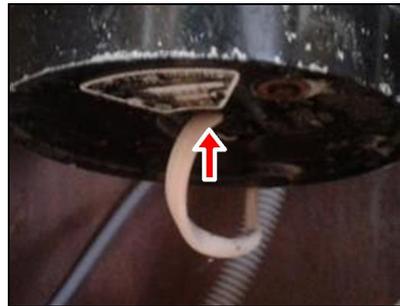
Observed improperly terminated wiring at the garbage disposal. A box connector or rubber gromet needs to be installed to prevent the wires from being damaged from vibration. Evaluation / Correction by a qualified electrical contractor is recommended for this entire condition.

Disposal wiring

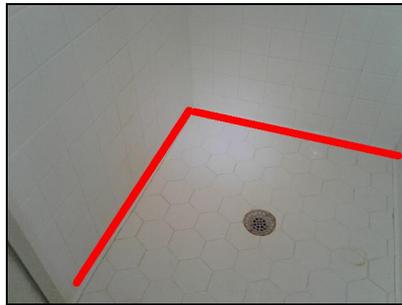
Master bath shower

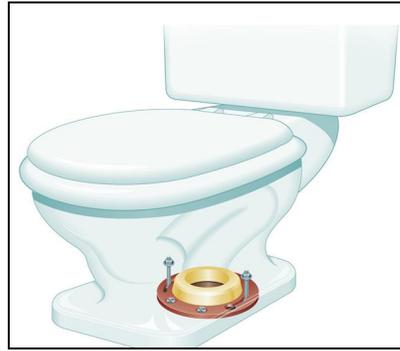
Observed that the first floor guest bathroom toilet is slightly loose at floor. If seal is broken it can damage flooring under toilet. Condition is conducive to leaking and other potential damages. Evaluation / Correction by a qualified handyman contractor is recommended for this entire condition.

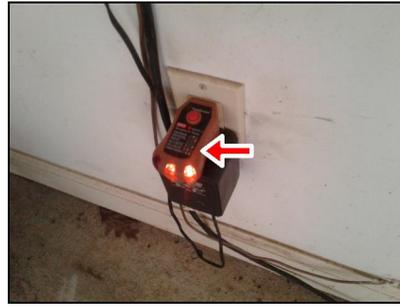
Observed that the Ground-fault Circuit-interrupter at the back wall of the garage failed to operate properly when tested. This may indicate a wiring problem or a defect with the device. Condition is conducive to potential safety hazards. Evaluation / Correction by a qualified electrical contractor is recommended for this entire condition.

Back wall of garage

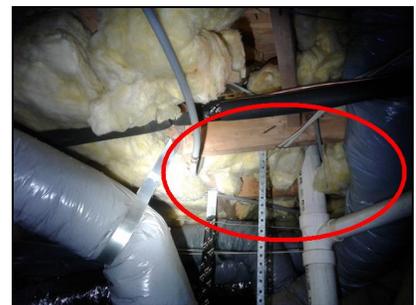
**Cut floor joist**

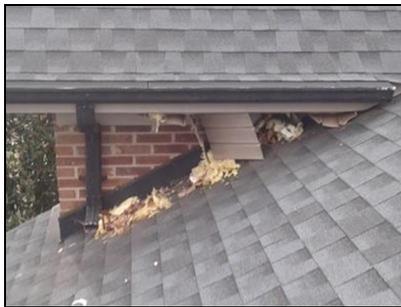
Upper front right

**1.1** Observed that the vinyl soffit is loose / pushed up / damaged in several location. Most of this damage is due too recent rodent penetrations at the upper attic areas (See exterior section of this report for further comments) Condition is conducive to other damages. Evaluation / Correction by a qualified contractor is recommended for this entire condition.

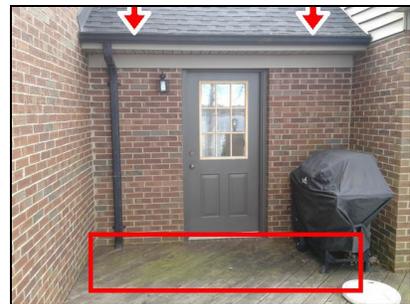
Gutters overflowing right rear

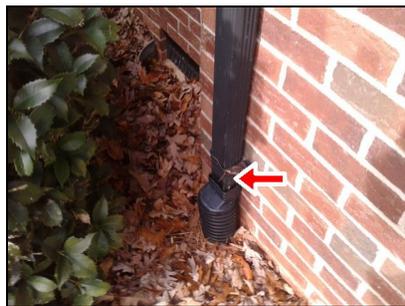
**1.6** Observed downspouts terminating at the foundation wall and missing diverter / splash block / leader pipes in various locations (See Photos). Providing an adequate roof drainage system, diverting all downspouts away from the foundation and providing adequate soil grading and ground cover at the foundation and throughout the site are primary remedial factors to consider for any water penetration concerns. Downspouts that run into the ground are subject to backup / blockage. Neither the presence nor integrity of underground lines, nor free flow of water through such lines is determinable as part of this inspection. Condition is conducive to water penetrations into crawl space and other areas. Evaluation / Correction by a qualified handyman contractor is recommended for this entire condition.

Underground drain system

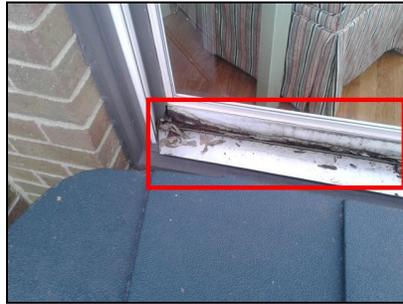
**2.3** Observed wood rot / decay / damage and deterioration at multiple window frames around the home. Condition is conducive to further damages. Evaluation / Correction by a qualified general contractor is recommended for this entire condition.

Rear family room windows

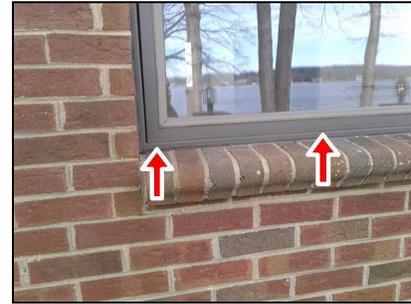
Check all windows

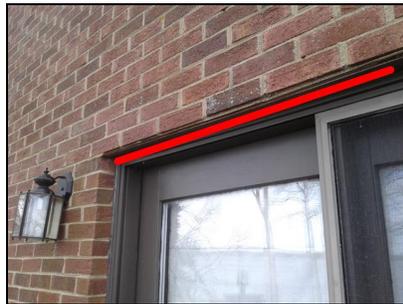
**2.3** Observed that all steel lintels over exterior windows and doors need to be rust proof painted. Condition conducive to rusting which in turn will expand the steel and cause mortar joint cracking. Evaluation / Correction by a qualified handyman contractor is recommended for this entire condition.

All exterior doors

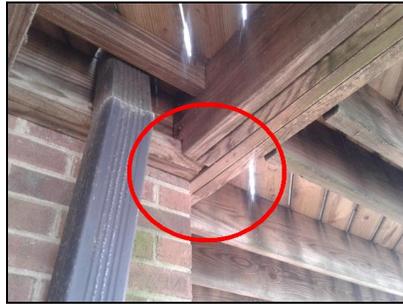
**2.6** Observed a support girder beam at the right rear corner of the deck where the floor joists change direction. The beam is pulling loose from the house wall and has dropped slightly. The support connection to the house wall is not adequate which has caused this settlement. Condition is conducive to further movement. Evaluation / Correction by a qualified general contractor is recommended for this entire condition.

Support girder beam

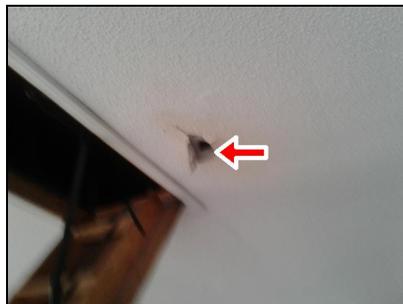
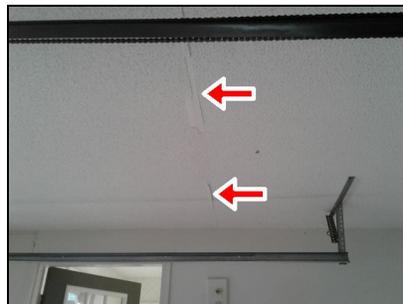
**4.1** The integrity of any fire-separation assembly must maintain a 20 minute fire rating for proper protection. Any gaps or openings should be covered and or sealed with suitable materials and all joints / holes must be drywall taped. Evaluation / Correction by a qualified handyman contractor is recommended for this entire condition.

Garage ceiling

Garage ceiling joints

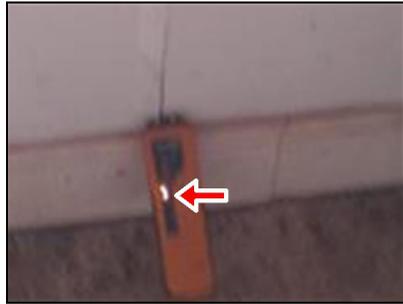
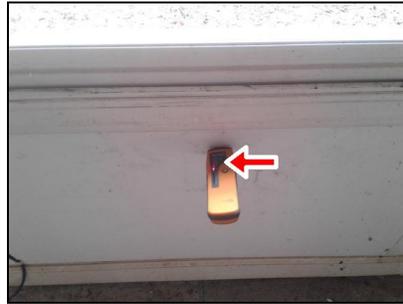
**4.1** Observed a high moisture content under one of the garage windows along the back wall. Exterior evidence points to a hole in the brick row lock and cracked caulking joints around this window. Condition is conducive to further damages. Evaluation / Correction by a qualified contractor is recommended for this entire condition.

Garage rear wall under window

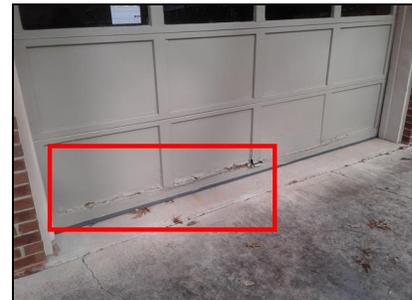
Bottom of garage doors

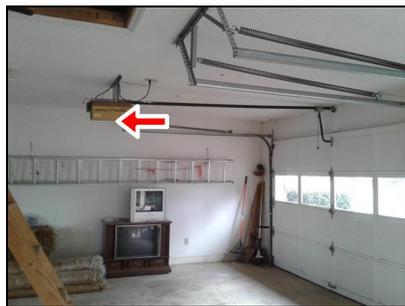
**4.3** Observed that all three of the garage door operators have various malfunction concerns. The first door on the right does not function at all. The middle door safety beams are not operating properly. The door opener on the left makes a grinding sound. Condition is conducive to further damages. Evaluation / Correction by a qualified garage door contractor is recommended for this entire condition.

GD1 operator not functional

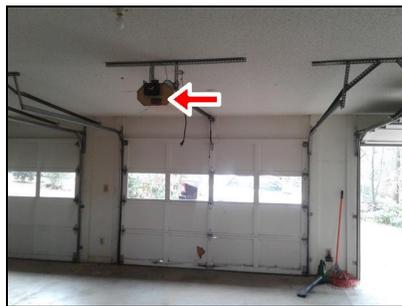
GD2 operator malfunctioning

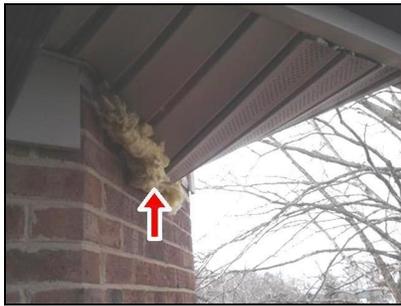
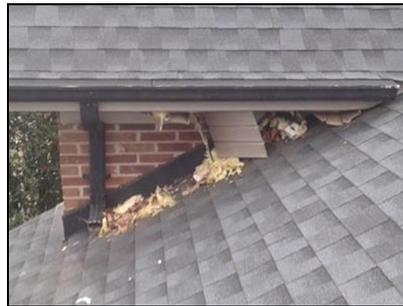
**5.5** Observed evidence of a large rodent penetration into the upper attic area. The soffit at the upper right overhang has been severely damaged and opened and there is evidence of animal droppings and damaged insulation in multiple locations. Condition is conducive to further damages. Evaluation / Correction by a qualified pest control contractor is recommended for this entire condition.

Rodent nesting

Front right overhang

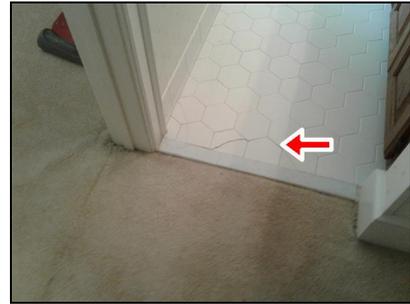
Cracked tile in master bath

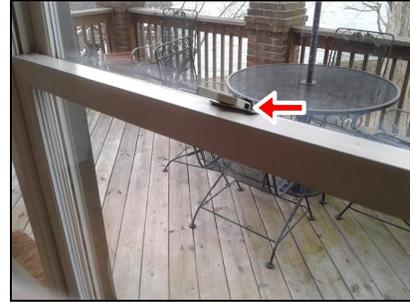
Check all windows

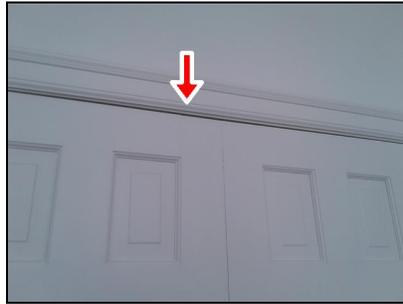
Second floor rear bedroom

**6.6** Observed that several of the room and closet doors hit and rub the door frames (See photos for locations) This is typically due to expansion and contraction from seasonal interior humidity. (Recommend checking all in all locations) Evaluation / Correction by a qualified handyman contractor is recommended for this entire condition.

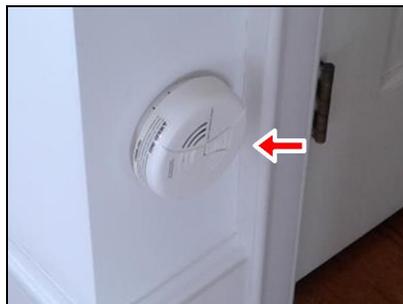
First floor

**6.7** Observed that none of the smoke / carbon monoxide detectors responded to testing. Replacement of units or batteries is recommended. Smoke / fire detection systems and fire extinguishers are generally recommended for all homes. Any installed systems should be checked / serviced at least monthly. Conditions are conducive to safety concerns. Evaluation / Correction by a qualified contractor is recommended for this entire condition.

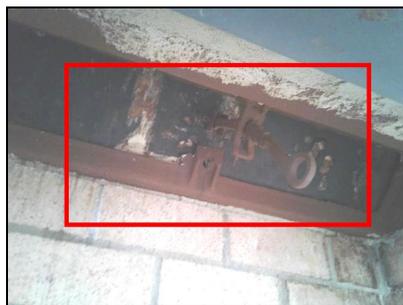
**6.9** Observed that the fireplace damper door does not have a safety clamp installed. The safety clamp will not allow the damper door to be closed completely. This is a safety concern due too fireplaces having gas logs installed. It was not possible determined if this gas logs were the non- vented type. Condition is conducive to a potential safety hazard. Evaluation / Correction by a qualified fireplace contractor is recommended for this entire condition.

Fireplace damper door

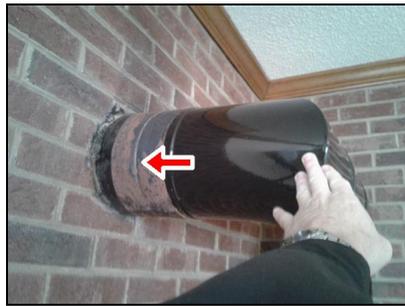
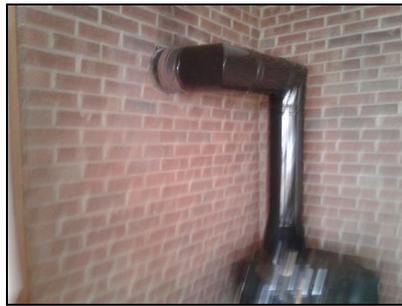
**6.10** Observed that the wood stove pipe in the basement was very loose were it passes through the wall. Condition is conducive to a potential safety hazard. Evaluation / Correction by a qualified fireplace contractor is recommended for this entire condition.

Wood stove pipe

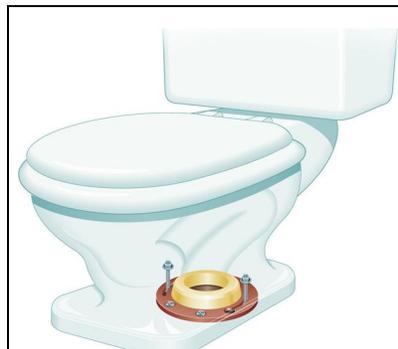
**8.1.C** Observed that the first floor guest bathroom toilet is slightly loose at floor. If seal is broken it can damage flooring under toilet. Condition is conducive to leaking and other potential damages. Evaluation / Correction by a qualified handyman contractor is recommended for this entire condition.

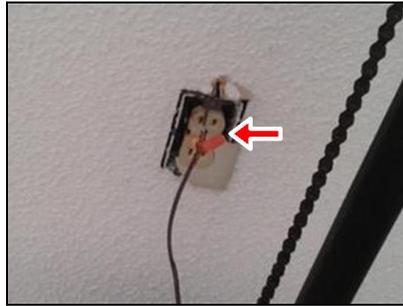
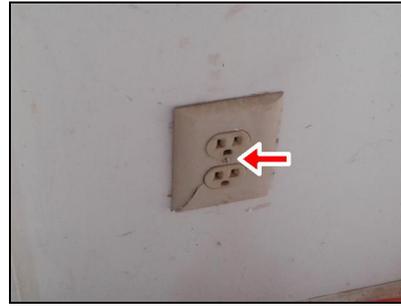
**9.4** Observed several missing / broken outlet / switch covers in multiple locations (See photos for locations). Condition is conducive to a safety hazard. Evaluation / Correction by a qualified handyman contractor is recommended for this entire condition.

Garage

Front wall garage

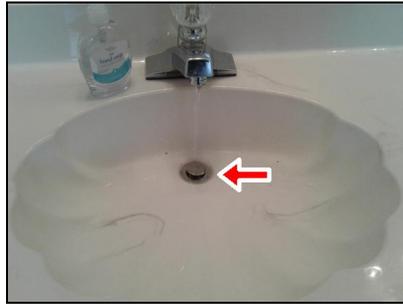
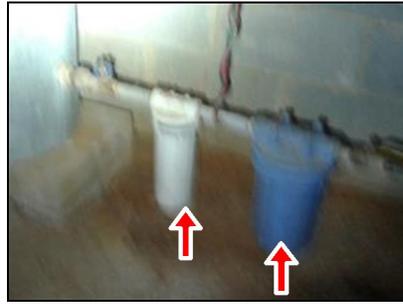
**10.1** Observed an odor and dirty water coming out of the plumbing system and water heater. This indicates sulfur and or some other form of bacteria is inside the water heater. Condition is conducive to further damages. Evaluation / Correction by a qualified plumbing contractor is recommended for the entire plumbing system followed up by a water quality test.

Stained water

Water fliters

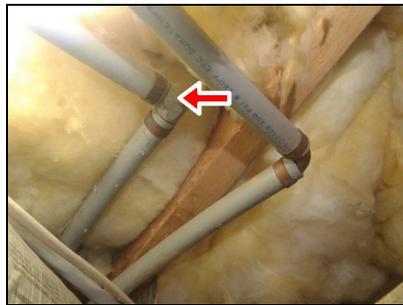
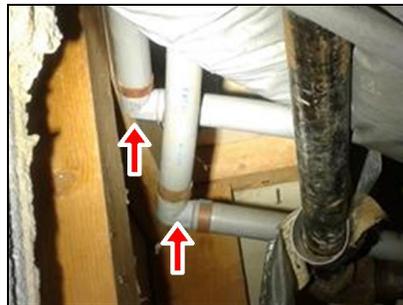
**10.1** Observed some polybutylene pipe fittings under the crawl space. The North Carolina Home Inspection Licensure Board officially recommends that the home inspector identify the potential concerns with polybutylene plumbing pipe. Polybutylene has been used for many years, but has had a higher than normal failure rate. Copper and Brass fittings used in later years have apparently reduced the failure rate. Condition is conducive to other potential damages. Evaluation / Correction by a qualified plumbing contractor is recommended for this entire condition.

Polybutylene pipe fittings

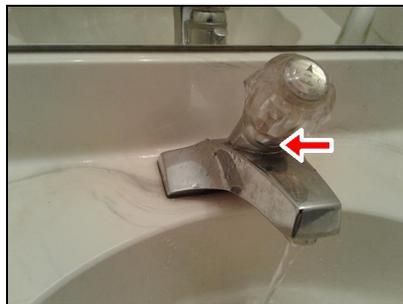
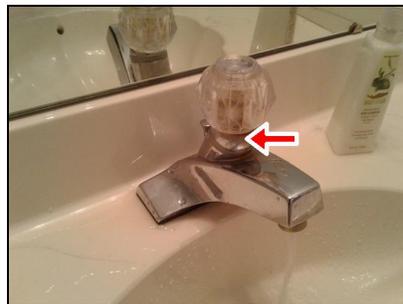
**10.2** Observed that water leaks out from under the first and second floor hall bath sink faucet handles when turned on. This is generally an indication that the rubber seals inside need to be replaced. Evaluation / Correction by a qualified plumbing contractor is recommended for this entire condition.

First floor hall bath

Second floor hall bath

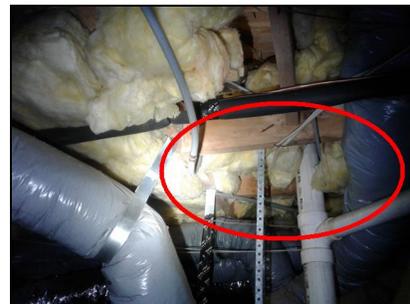
Cut floor joist
