# FIVE STAR HOME INSPECTIONS

## FIVE STAR HOME INSPECTION

1234 Main Street  
Davidson , NC 28036

09/06/2026 9:00AM

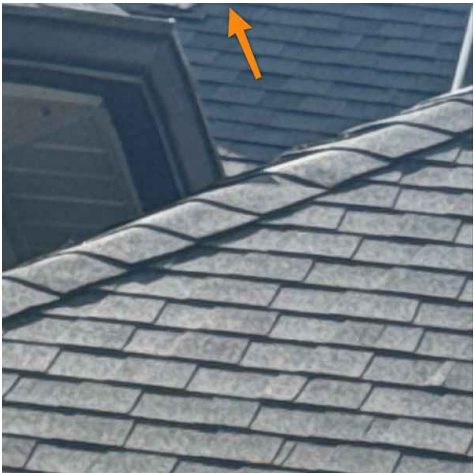
Next to chimney

#### LOOSE SHINGLES

Observed loose shingles in several areas of the roof. This is due to expansion and contraction which is typical and very common with most homes. Condition is conducive to water penetrations. Evaluation / Correction by a qualified roofing contractor is recommended for this entire condition. (See photos for locations / direction).

Recommendation  
Contact a qualified roofing contractor

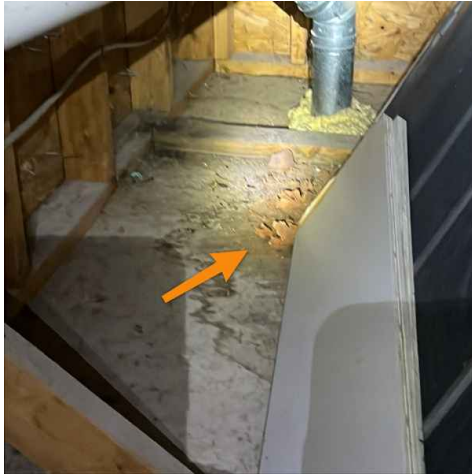
Inside bonus room attic

#### PREVIOUS ROOF LEAK

Observed previous water damage / stained roof decking inside the attic. This indicates the roof or flashing has experienced water penetration in the past, which may have caused damage to underlying structures or insulation. Condition is conducive to other damages / concern. Evaluation / Correction by a qualified general / roofing contractor is recommended for this entire condition. [\(See photos for locations / direction\)](#).

Contact a qualified general contractor.

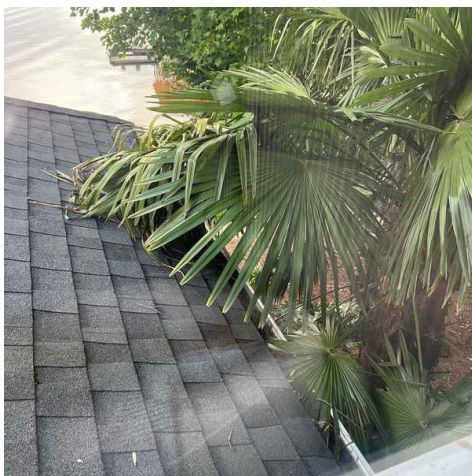
Multiple locations

Observed evidence of guttering filled with debris, keep clean for proper function. Condition is conducive to further damages / water penetrations into the home, crawl space, and/or basement. All gutters should be checked for damage, blockage, or overflow on a regular basis (at least twice annually). Gutter guards may help in cases where leaves and other debris routinely accumulate in a short period of time. Evaluation / Correction by a qualified handyman contractor is recommended for this entire condition. [\(See photos for locations / direction\)](#).

Contact a qualified handyman contractor

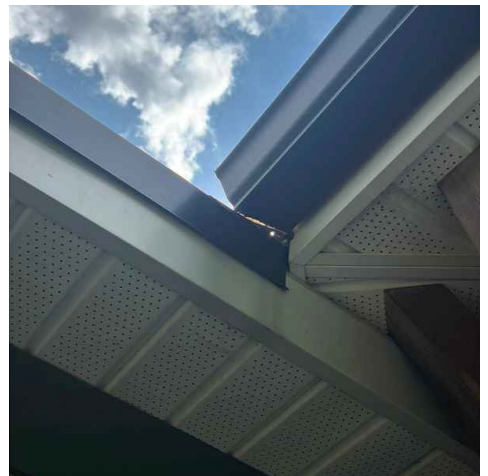
Master bedroom / outside deck

#### LEAKING GUTTERS

Observed evidence of guttering or gutter joints that leak. All gutters should be checked for damage, blockage, or overflow on a regular basis (at least twice annually). Gutter leaks should be sealed or the affected sections replaced by a qualified professional to prevent water intrusion and structural damage. Evaluation / Correction by a qualified gutter contractor is recommended for this entire condition. ([See photos for locations / direction](#)).

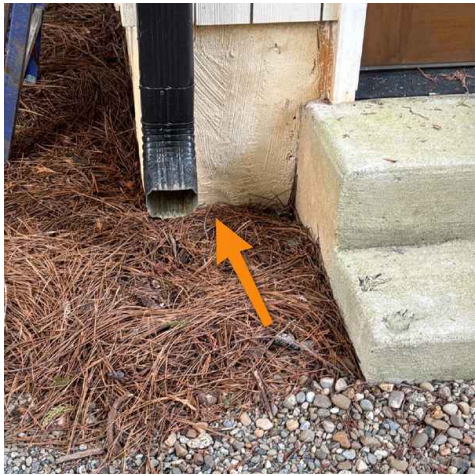
Garage

Observed downspouts terminating at the foundation wall and missing diverter / splash block / leader pipes in various locations. Providing an adequate roof drainage system, diverting all downspouts away from the foundation and providing adequate soil grading and ground cover at the foundation and throughout the site are primary remedial factors to consider for any water penetration concerns. Evaluation / Correction by a qualified handyman contractor is recommended for this entire condition. ([See photos for locations / direction](#)).

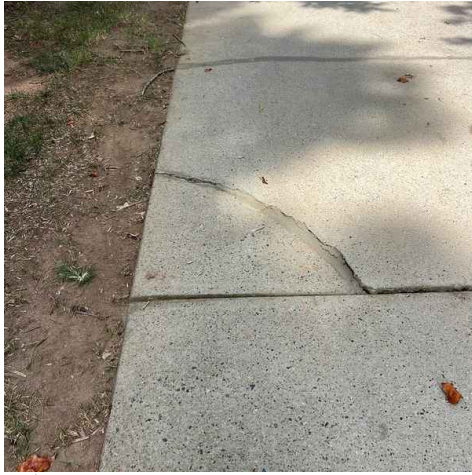
Driveway

### CRACKING / DISPLACEMENT

Observed sections of the driveway that are cracked / raised up with some displacement. Although concrete movement and typical cracking is common in almost every home this condition poses a safety (tripping) hazard. Evaluation / Correction by a qualified concrete contractor is recommended for this entire condition. (See photos for locations / direction).

Contact a qualified concrete contractor.

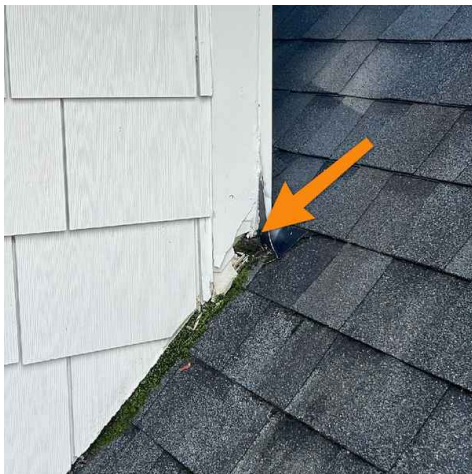
Left rear above master bedroom

#### COMPOSITE / WOOD SIDING & TRIM DAMAGE

Observed damage / deterioration / loose / warped pieces of siding and trim at multiple areas. Areas that were observed are from ground level (only) but there may be additional repairs needed higher up and or out of view. Open gaps can allow moisture to enter behind the exterior wall covering and cause water penetration damages. Evaluation / Correction by a qualified siding contractor is recommended for the entire wood exterior condition. (See photos for locations / direction)

Contact a qualified siding specialist.

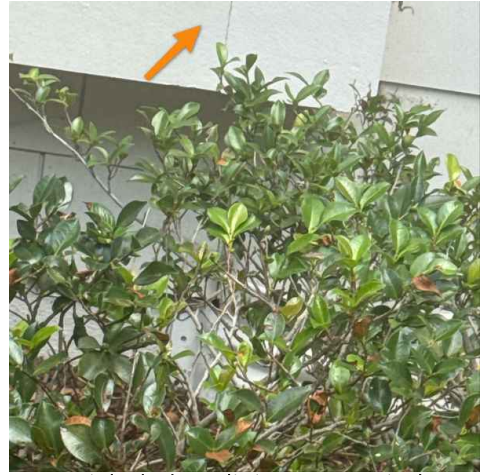
Front right below dining room window

Observed window trim and/or frames are in need of repair / replacement, painting and/or caulk sealing. Condition is conducive to potential water penetrations and further damages. Visual observations are from ground level (only), there may be additional repairs needed higher up and / or out of view. Evaluation / Correction by a qualified siding / handyman contractor is recommended for this entire condition. (See photos for locations / direction).

Contact a qualified handyman contractor

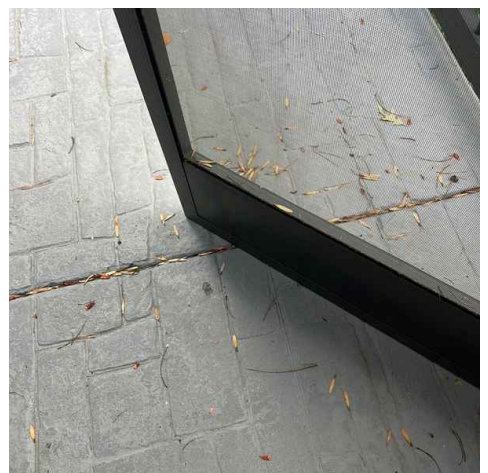
Screen door to master deck area

Observed storm doors that were hitting the floor deck. Condition is conducive to the doors closing abruptly which may cause damage to the doors or create a safety hazard. Evaluation / Correction by a qualified handyman contractor is recommended for this entire condition. (See photos for location.)

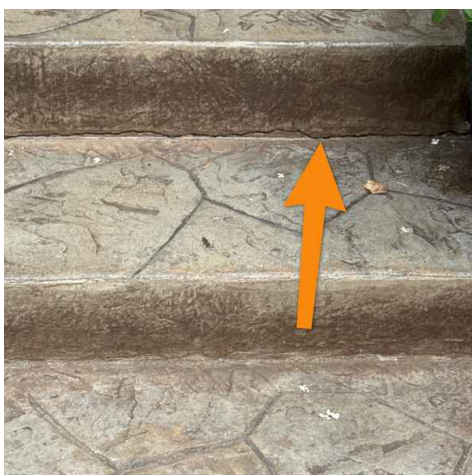
Front stairs

#### MINOR CRACKING

Observed typical cracking in the front stoop surface with no displacement. Small cracks in concrete are common due to normal settling and temperature fluctuations. While not immediately urgent, monitoring these cracks and addressing them proactively can prevent water infiltration and further deterioration. Recommend sealing of cracks as needed / desired by a qualified handyman contractor and then subsequent observation. ([See photos for locations / direction](#))

Contact a qualified handyman contractor

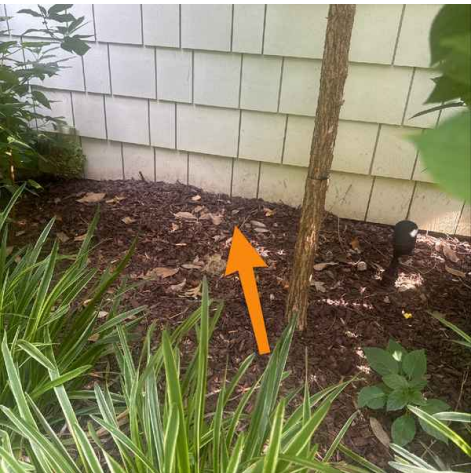
Garage front left below window

Observed soil / landscaping material / tree debris in contact with the siding / building. Condition is conducive to attracting wood destroying insects and moisture penetration concerns. Evaluation / Correction by a qualified landscaping contractor is recommended for this entire condition. ([See photos for locations / direction](#)).

Contact a qualified landscaping contractor

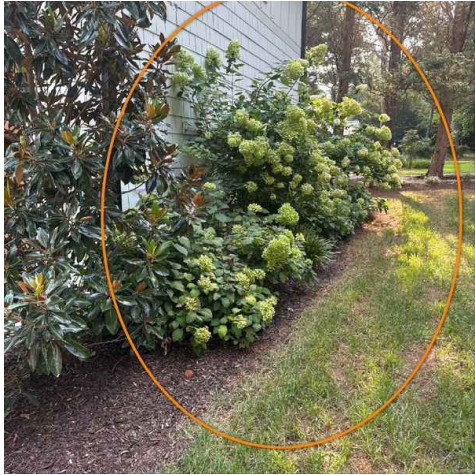
Exterior multiple locations

Observed vegetation that is in direct contact with building materials. Cutting back at least 12 inches is recommended. Condition is conducive to further damages. Evaluation / Correction by a qualified landscaping contractor is recommended for this entire condition. (See photos for locations / direction)

Contact a qualified landscaping contractor

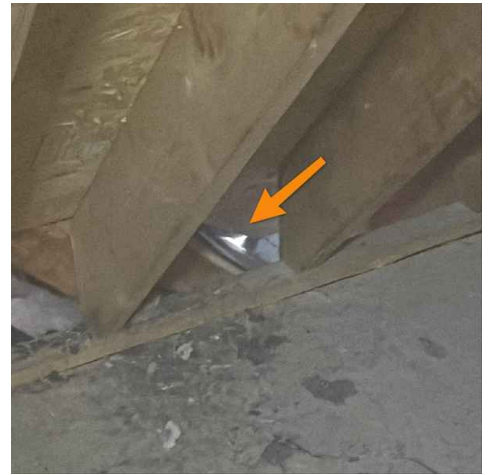
Right rear attic

Observed an opening / daylight at the right rear attic area. This is a potential area for rodent penetration and should be sealed off. Evaluation / Correction by qualified handyman contractor is recommended for this entire condition. (See photos for locations / direction).

Contact a qualified pest control contractor

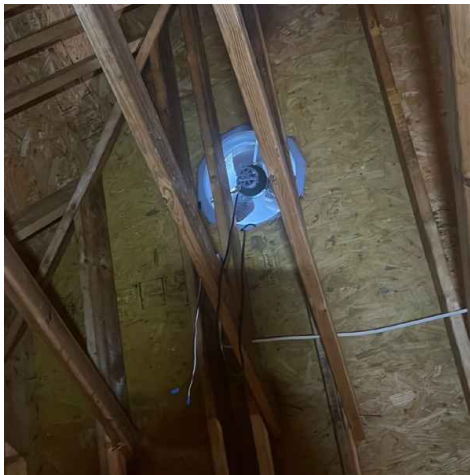
Attic fan Inoperable

Contact a qualified roofing / general contractor

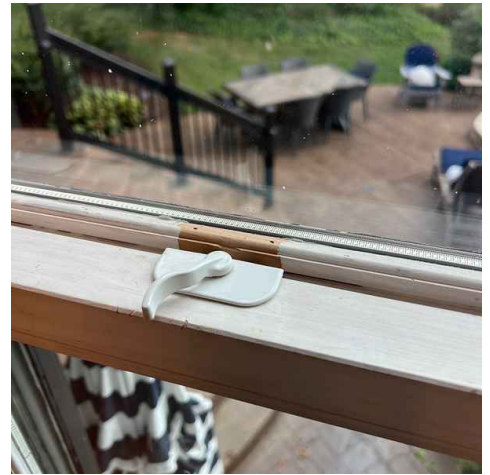
Rear breakfast room

Observed a window at the rear breakfast room is missing a latch. Window latches are essential safety features that prevent unauthorized entry and allow occupants to secure the home. Non-functional latches compromise home security and may also affect window operation and weathertightness. Condition is conducive to improper functionality and a safety hazard. Evaluation / Correction by a qualified handyman contractor is recommended for this entire condition. (See photos for locations / direction)

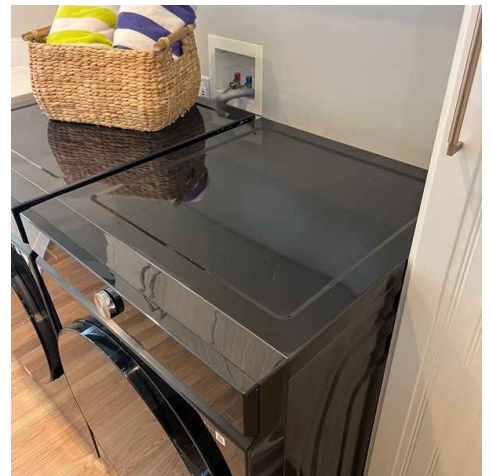
#### DRYER VENTS NOT INSPECTED

Observed that the dryer vent system could not be evaluated due to the following reasons. Vertical / Horizontal construction and length of vent system / Installed appliance limiting access and visibility / Storage items blocking access. Dryer vents are critical components that remove moisture and lint from the dryer to the exterior of the home. Blockages or improper venting can reduce dryer efficiency, create fire hazards, and potentially allow moisture to accumulate within wall cavities. All dryer vents should be checked / serviced annually by a qualified contractor / handyman to prevent the risk of fire.

Dryer vent connected

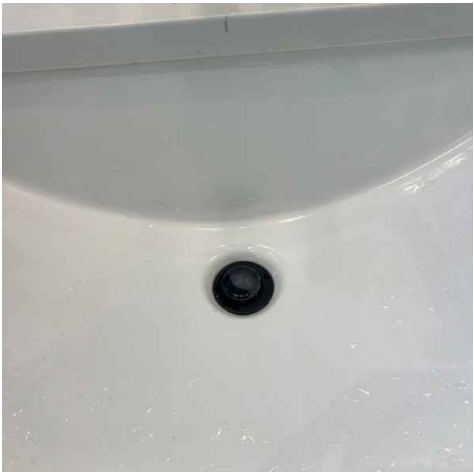
Master bath right sink

Observed that the bath sink drain stopper did not function properly and is damaged / disconnected / missing / did not hold water. This is typical due to lack of maintenance and is a condition conducive to further damages. Evaluation / Correction by a qualified plumbing contractor is recommended for this entire condition. (See photos for locations / direction).

Recommendation  
Contact a qualified plumbing contractor.

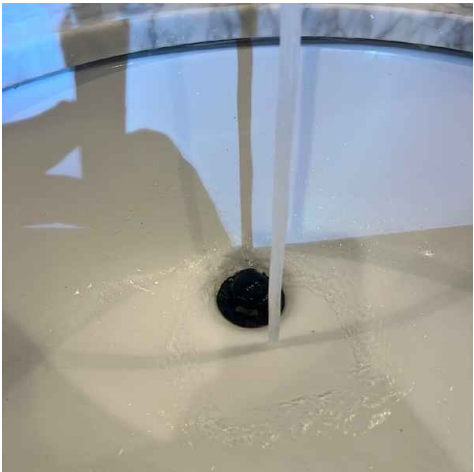
Observed that the girls bath sink drain stopper did not function properly and is damaged / disconnected / missing / did not hold water. This is typical due to lack of maintenance and is a condition conducive to further damages. Evaluation / Correction by a qualified plumbing contractor is recommended for this entire condition. (See photos for locations / direction).

Drain stopper malfunctioning

Recommendation  
Contact a qualified plumbing contractor.

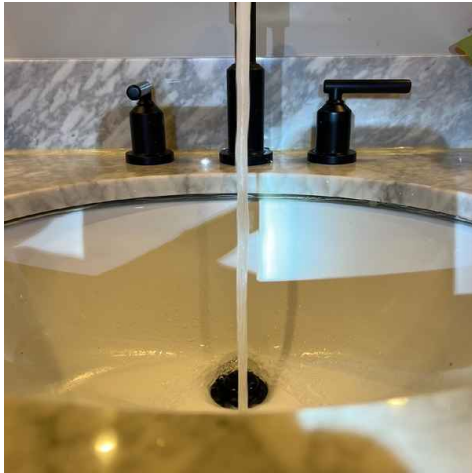
Sink disconnected from countertop

Contact a qualified plumbing contractor.

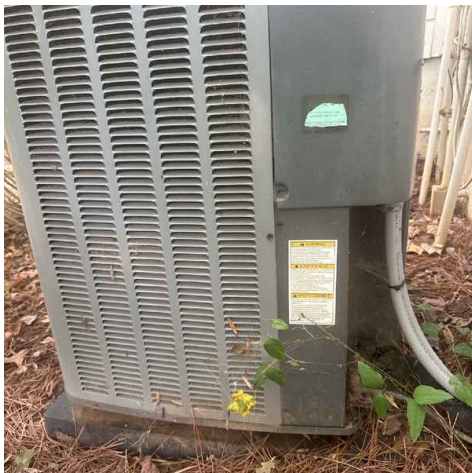
House Amana unit

Observed that the condenser unit needs to be fully cleaned and serviced. There was a significant amount of blockage around the outer coils which could be a contributing factor to the AC performance. Over time, a dirty condenser forces the unit to work harder, increasing energy consumption and potentially shortening equipment lifespan. Condition is conducive to other damages. Evaluation / Correction by a qualified HVAC contractor is recommended for this entire condition. (See photos for locations / direction)

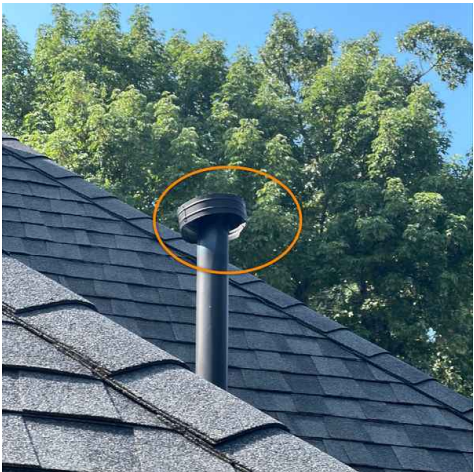
Observed that the top cap for the water heater vent located at the left rear over the master bedroom is dislodged. This can compromise the safe operation of the heating system and may allow combustion gases to enter the home. Proper venting ensures that all CO and moisture get dispersed from the home. Condition is conducive to a potential safety hazard. Evaluation / Correction by a qualified HVAC contractor is recommended for this entire condition. (See photos for location and directions)

Second floor gas heater vent cap

Recommendation  
Contact a qualified hvac contractor

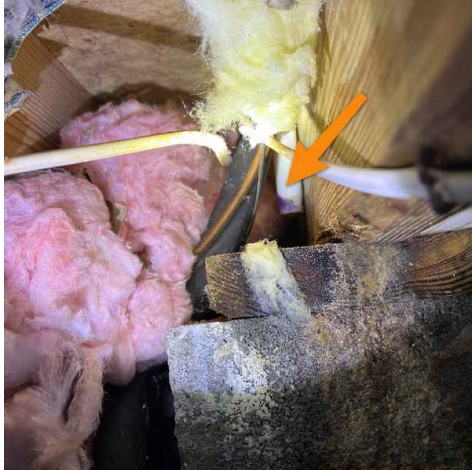
Drain line not connected Middle Front in CS

Contact a qualified hvac contractor

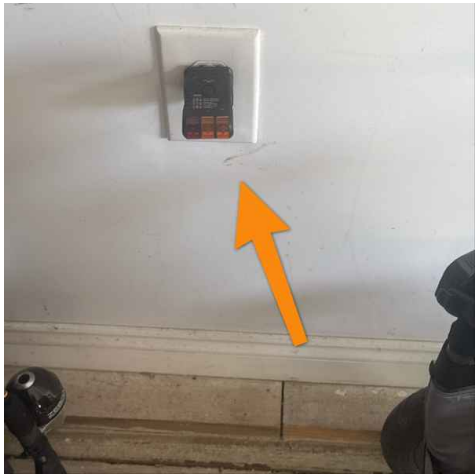
Attached garage right wall

Observed that the Ground-fault Circuit-interrupter failed to operate properly when tested. GFCI (Ground Fault Circuit Interrupter) outlets are required in wet or damp locations to protect against electrical shock hazards. This may indicate a wiring problem or a defect with the device. Condition is conducive to potential safety hazards. Evaluation / Correction by a qualified electrical contractor is recommended for this entire condition. (See photos for location and directions).

Recommendation  
Contact a qualified electrical contractor.

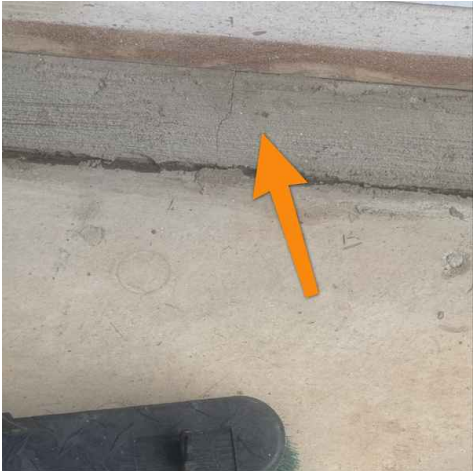
Apartment garage right wall

Observed typical cracks in the sides of the slab foundation. This is typical due to normal masonry product shrinkage. No displacement at the time of inspection was observed. Seal as needed to prevent water penetrations and subsequently monitor conditions. Evaluation / Correction by a handyman contractor is recommended for this entire condition. (See photos for locations / direction)

Recommendation  
Contact a qualified handyman contractor
