**James Jones**

**123 Second Street  
USA**

May 06, 2020

## General Summary

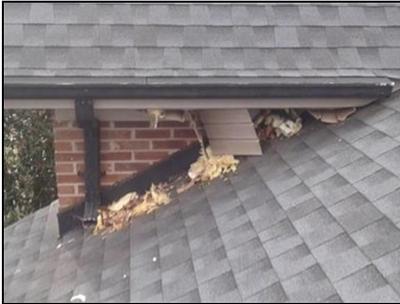
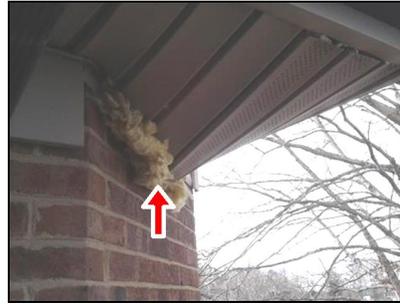
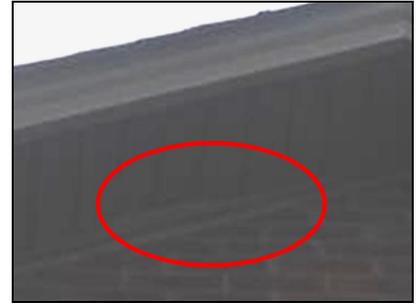
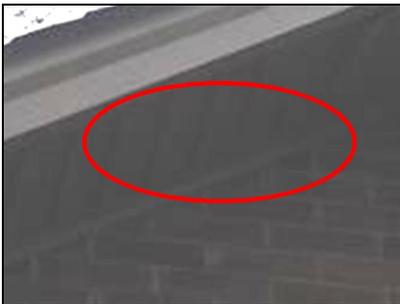
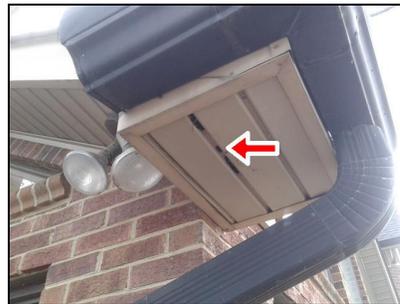
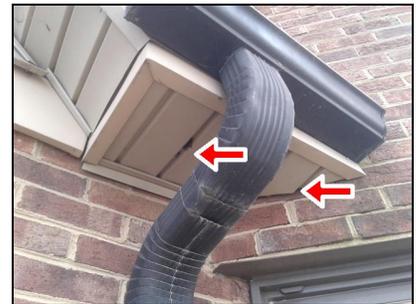
Observed that the vinyl soffit is loose / pushed up / damaged in several location. Most of this damage is due too recent rodent penetrations at the upper attic areas (See exterior section of this report for further comments) Condition is conducive to other damages. Evaluation / Correction by a qualified contractor is recommended for this entire condition.

Upper front right

Upper middle rear

Right side peak

Left side of garage

Lower rear overhang

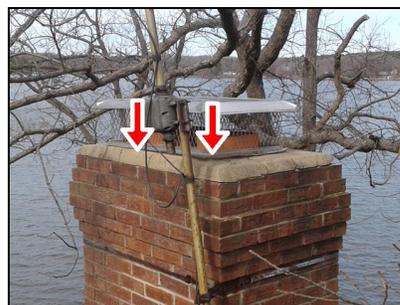
Top of chimney

Observed cracked areas of the chimney mortar cap and open areas between cap and flue liner. Conditions are conducive to water penetrations at interior of chimney / fireplace. Seal with proper material to avoid water penetrations. Evaluation / Correction by a qualified chimney contractor is recommended for this entire condition.

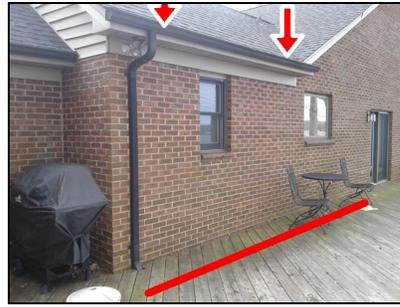
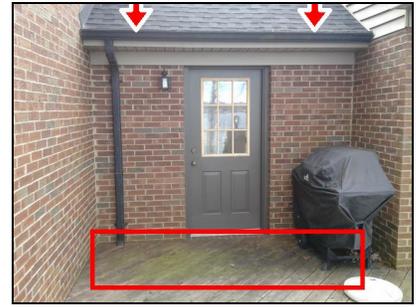
Observed multiple gutters filled with debris, keep clean for proper function. All gutters should be checked for damage, blockage, or overflow on a regular basis (at least twice annually). Gutter guards may help in cases where leaves and other debris routinely accumulate in a short period of time. Condition is conducive to further damages. Evaluation / Correction by a qualified handyman contractor is recommended for this

Gutters overflowing right rear

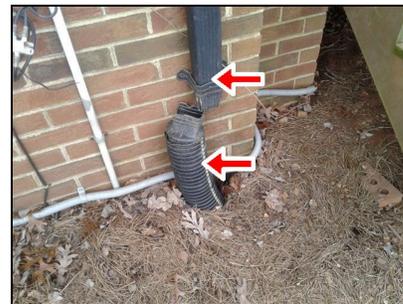
Observed downspouts terminating at the foundation wall and missing diverter / splash block / leader pipes in various locations (See Photos). Providing an adequate roof drainage system, diverting all downspouts away from the foundation and providing adequate soil grading and ground cover at the foundation and throughout the site are primary remedial factors to consider for any water penetration concerns. Downspouts that run into the ground are subject to backup / blockage. Neither the presence nor integrity of underground lines, nor free flow of water through such lines is determinable as part of this inspection. Condition is conducive to water penetrations into crawl space and other areas. Evaluation / Correction by a qualified handyman contractor is recommended for this entire condition.

Downspouts disconnected

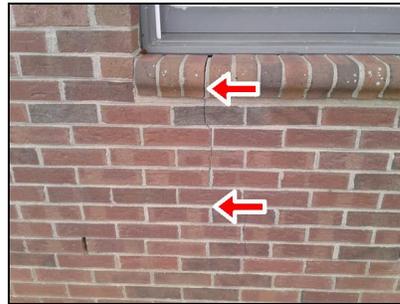
Observed small cracks in the brick veneer at the rear garage wall . These are typical in nature due to age and normal masonry shrinkage. Although small cracks in brick veneers are typical, these areas should be resealed too prevent any water penetrations or damages. Evaluation / Correction by a qualified handyman contractor is recommended for this entire condition.

Small crack @ rear garage wall

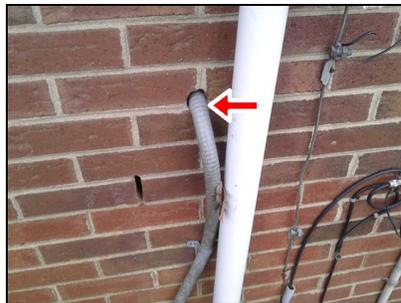
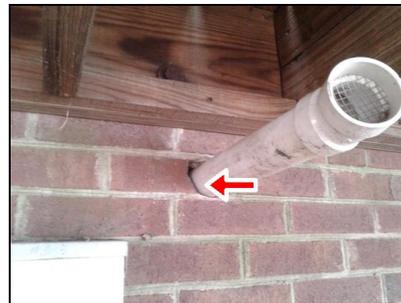
Observed that caulk sealing is needed at all pipes / wires were they pass through the house wall (See photos for locations). Condition is conducive to potential water penetrations and other damage. Evaluation / Correction by a qualified handyman contractor is recommended for this entire condition.

Right side

Right side under deck

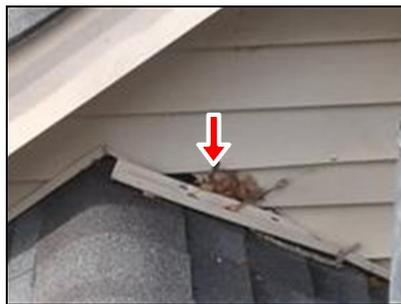
Above garage entry roof

Observed holes and damaged areas of siding and trim at various locations (See photos for locations). Areas that were observed are from ground level (only) but there may be additional repairs needed higher up and / or out of view. Condition is conducive to potential water penetrations. Evaluation / Correction by a qualified handyman contractor is recommended for this entire condition.

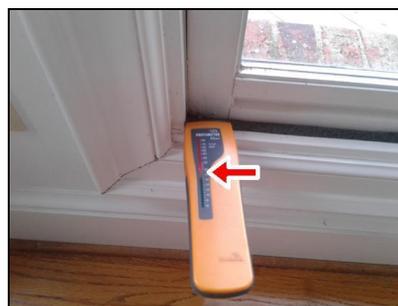
**Observed wood rot / decay / damage and deterioration at multiple window frames around the home. Condition is conducive to further damages. Evaluation / Correction by a qualified general contractor is recommended for this entire condition.**

High moisture breakfast room window frames

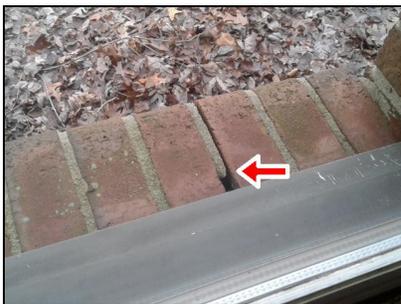
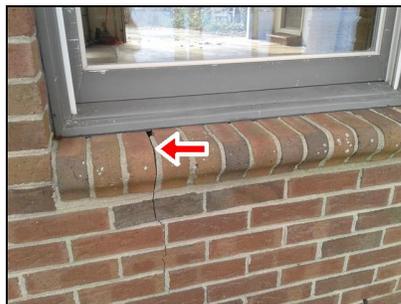
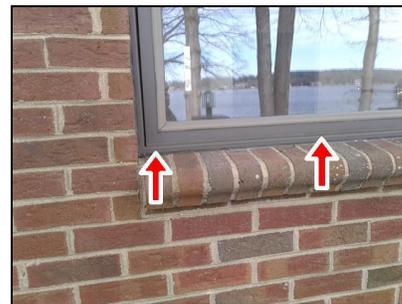
**Observed that the caulk sealing needs to be re-done at all windows and exterior doors where the brick meets the window and door frames. Condition is conducive to potential water penetrations. Evaluation / Correction by a qualified handyman contractor is recommended for this entire condition.**

Back wall of garage

Check all windows

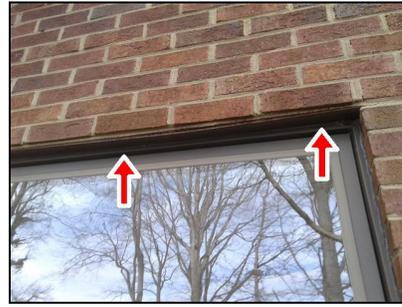
**Observed that all steel lentils over exterior windows and doors need to be rust proof painted. Condition conducive to rusting which in turn will expand the steel and cause mortar joint cracking. Evaluation / Correction by a qualified handyman contractor is recommended for this entire condition.**

All exterior windows

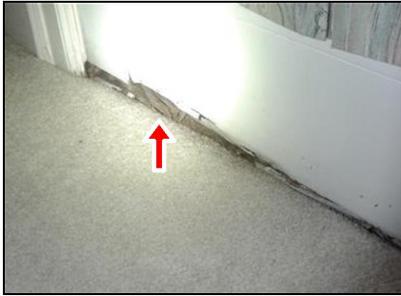
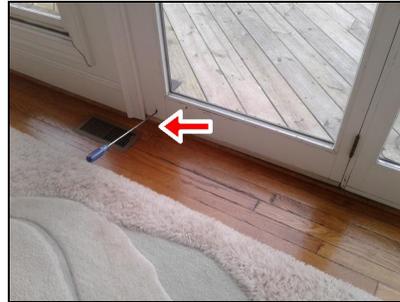
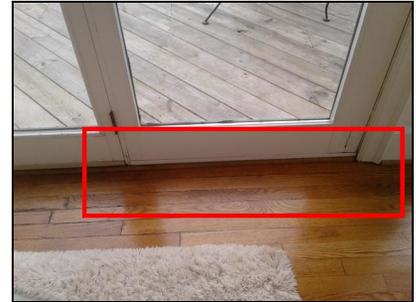
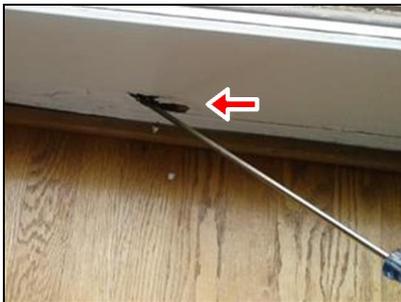
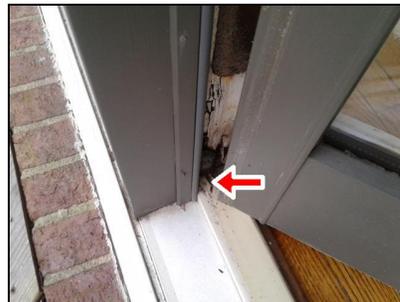
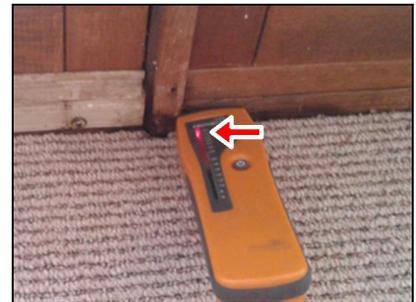
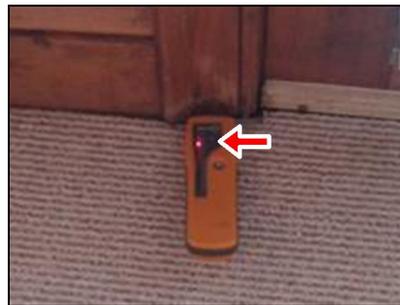
Observed wood rot / decay at several exterior door panels and frames (See photos for locations). The damage to the master bedroom / family room / breakfast room door panels is severe enough to warrant replacement. This is typically due too and a common problem with poor maintenance of the caulk joints at these locations. Condition is conducive to further damages. Evaluation / Correction by a qualified general contractor is recommended for this entire condition.

Master bedroom

Family room

Breakfast room

Basement french doors

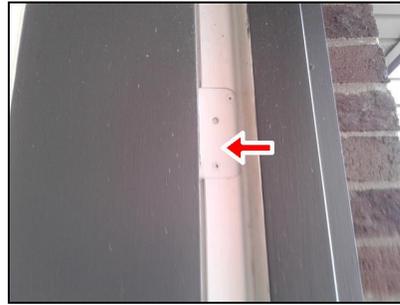
Rear door

Observed missing hinges screws at several exterior doors (See photos for locations) Condition is conducive to door sagging, rubbing over a period of time. Evaluation / Correction by a qualified handyman contractor is recommended for this entire condition.

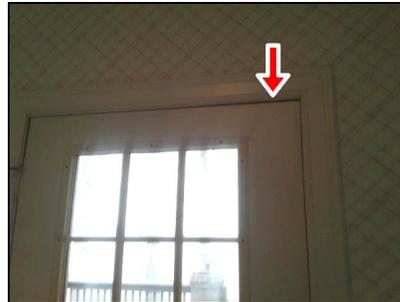
Rear door

Observed that the rear door rubs / hits the frame. Condition is conducive to further damages. Evaluation / Correction by a qualified handyman contractor is recommended for this entire condition.

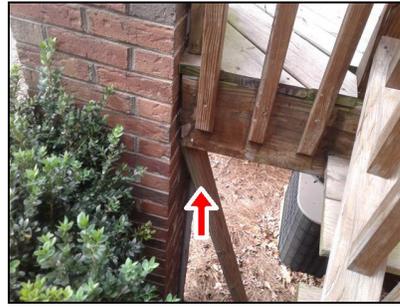
Left side of deck

Observed that the left side of the deck and stairs have dropped slightly. The frame has also come loose from the first brick column. It appears that the brick columns itself has settled slightly over a period of time causing this damage. Further / Evaluation / Correction by a qualified general contractor is recommended for this entire condition.

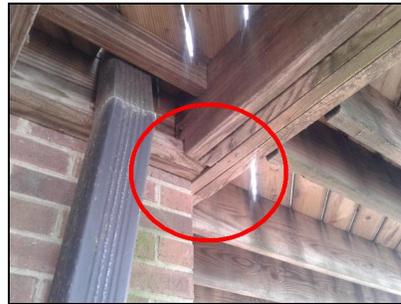
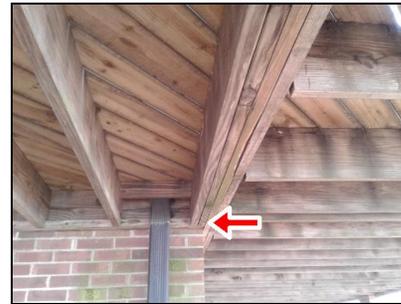
Observed a support girder beam at the right rear corner of the deck where the floor joists change direction. The beam is pulling loose from the house wall and has dropped slightly. The support connection to the house wall is not adequate which has caused this settlement. Condition is conducive to further movement. Evaluation / Correction by a qualified general contractor is recommended for this entire condition.

Support girder beam

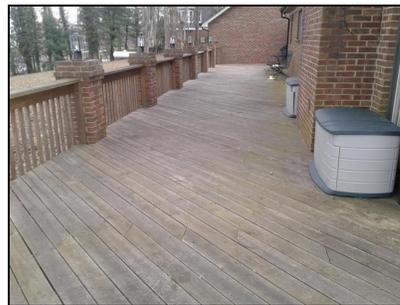
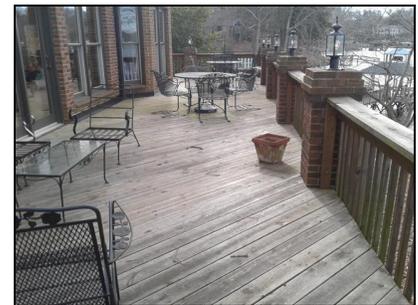
Observed decking and railings to have cracked / deteriorated materials in various areas and some nails are backing out. Repair / replace cracked and deteriorated materials as needed and for weathered deck surfaces we recommend sealing wood as needed and resetting nails. Condition is conducive to further damages. Evaluation / Correction by a qualified general / handyman contractor is recommended for this entire deck / condition.

Main deck surface

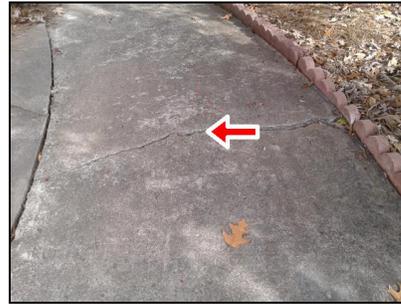
Observed sections of the concrete walkways that are raised up. Although concrete movement and typical cracking is common in almost every home this condition poses a safety (tripping) hazard. Evaluation / Correction by a qualified contractor is recommended for this entire condition.

Lead walk to dock

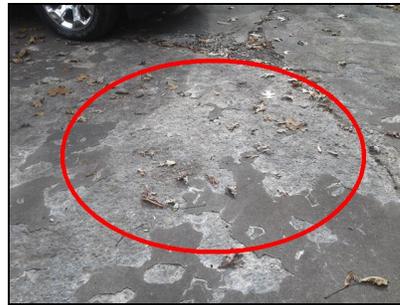
Driveway

Observed sections of the driveway that are raised up with some displacement. Although concrete movement and typical cracking is common in almost every home this condition poses a safety (tripping) hazard. Evaluation / Correction by a qualified general / concrete contractor is recommended for this entire condition.

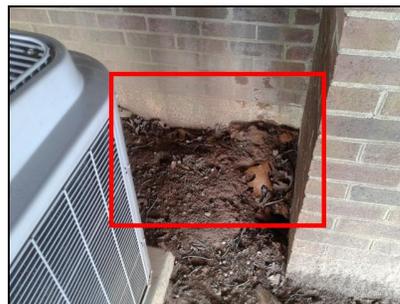
Right rear

Observed a negative / flat grade slope toward the right rear corner of the foundation. This could allow water runoff and ponding which could lead to water penetrations into the crawl space and other concerns. Suitable drainage conditions need to be maintained and in order to prevent any future problems. Evaluation / Correction by a qualified handyman contractor is recommended for this entire condition.

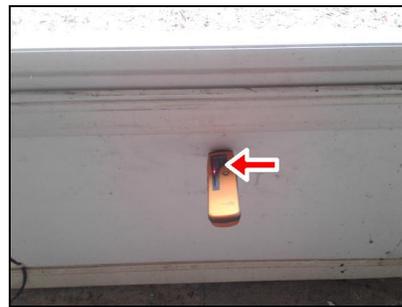
Observed a high moisture content under one of the garage windows along the back wall. Exterior evidence points to a hole in the brick row lock and cracked caulking joints around this window. Condition is conducive to further damages. Evaluation / Correction by a qualified contractor is recommended for this entire condition.

Garage rear wall under window

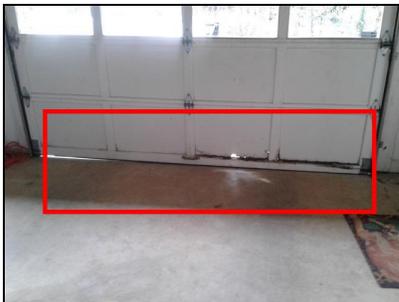
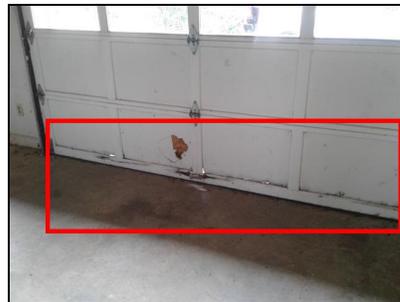
Observed that all three of the garage doors at wood rot / and moisture damages at the bottom panels and other various locations. Condition is conducive to further damages. Evaluation / Correction by a qualified garage door contractor is recommended for this entire condition.

Bottom of garage doors

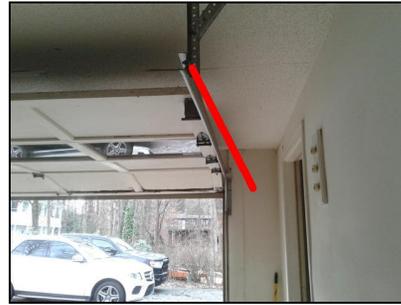
Observed that the garage door that is closest to the house entrance is missing the door springs. Condition is conducive to further damages. Evaluation / Correction by a qualified garage door contractor is recommended for this entire condition.

GD 3 door springs

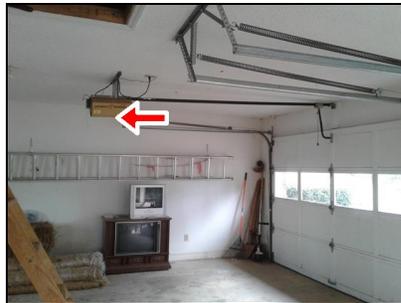
Observed that all three of the garage door operators have various malfunction concerns. The first door on the right does not function at all. The middle door safety beams are not operating properly. The door opener on the left makes a grinding sound. Condition is conducive to further damages. Evaluation / Correction by a qualified garage door contractor is recommended for this entire condition.

GD1 operator not functional

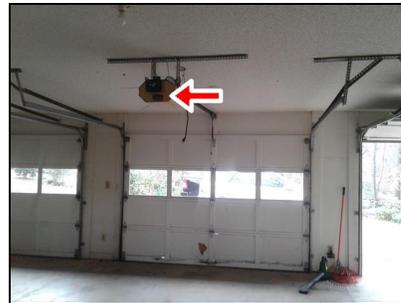
GD2 operator malfunctioning

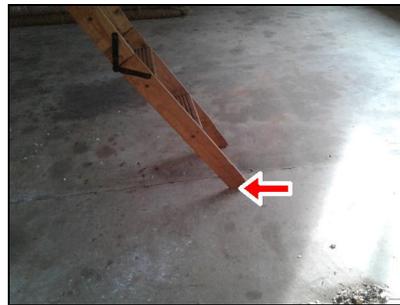
Garage attic stairs

Observed that the garage attic stair unit steps needs to be cut off so the ladder is on a flat plane. This condition is conducive to stressing the ladder joints. Evaluation / Correction by a qualified handyman contractor is recommended for this entire condition.

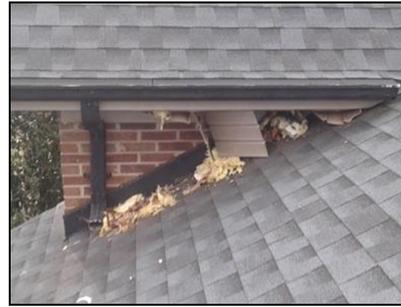
Front right overhang

Observed evidence of a large rodent penetration into the upper attic area. The soffit at the upper right overhang has been severely damaged and opened and there is evidence of animal droppings and damaged insulation in multiple locations. Condition is conducive to further damages. Evaluation / Correction by a qualified pest control contractor is recommended for this entire condition.

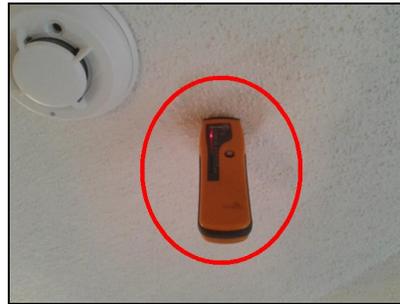
Second floor ceiling

Observed previous water staining at the second floor hall ceiling which was due to a previous roofing leak. Moisture tests were performed at all locations with positive results. Condition is conducive to further damages. Evaluation / Correction by a qualified contractor is recommended for this entire condition.

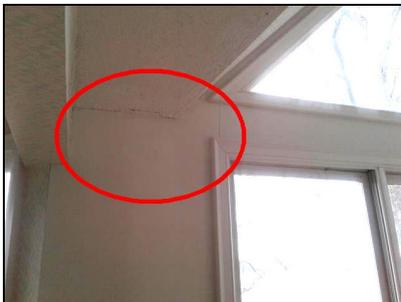
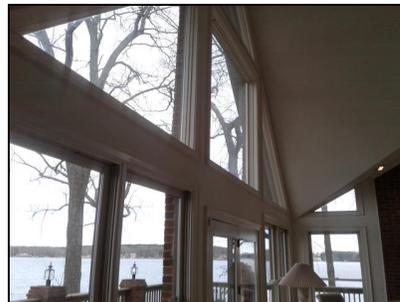
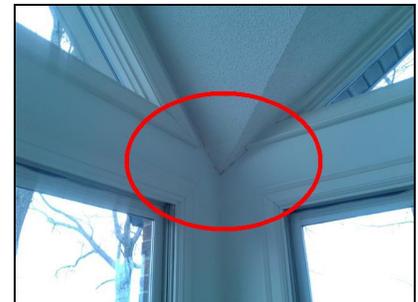
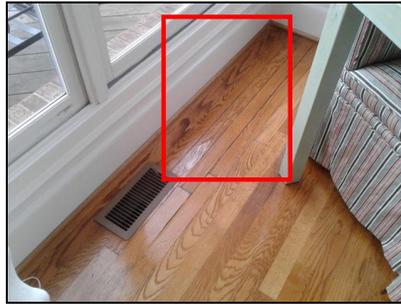
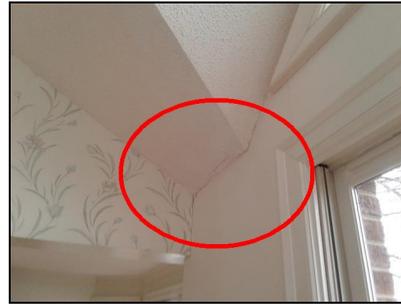
Observed evidence of previous water stains / damaged wood flooring and cracks at the exterior of the brick veneer. Due to roof and wall design this evidence points to previous water penetrations along this wall in various locations. Condition is conducive to further damages. Due to finished wall materials and limitation of visible damages, further investigation / Evaluation / Correction by a qualified general contractor is recommended for this entire condition.

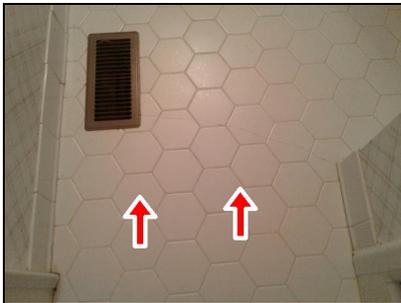
First floor bath floor

Observed evidence of previous movement in the floor that is under the laundry room / first floor bath / and master bedroom. The substructure / floor joists under this area were viewed with some damage. (See foundation section for further comments) Further Evaluation / Correction by a qualified contractor is recommended for this entire condition.

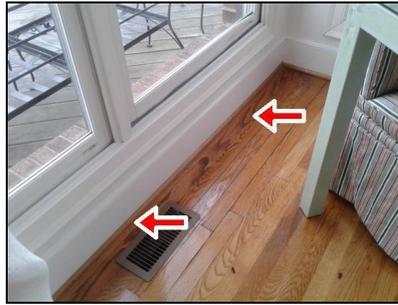
Family room

Observed water damaged wood flooring at the family room wall. See Interior Wall section of this report for further comments.

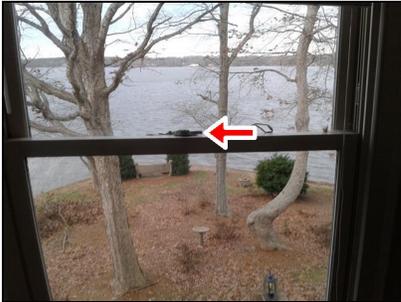
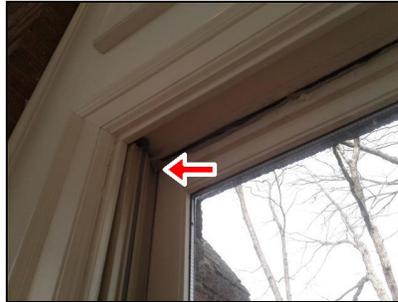
Observed multiple windows throughout the home that do not functioning as intended and are most likely painted shut / have broken spring balances or hardware that is difficult to operate. This condition is a concern in regards to safety conditions and egress in case an emergency exit is needed. (Recommend checking all in all locations). Evaluation / Correction by a qualified general contractor is recommended for this entire condition.

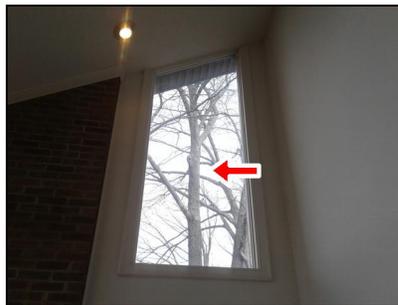
Observed broken vacuum seals at several windows (See photos for locations) Replacement of insulated glass windows or doors is usually required to correct failed vacuum seals. Evaluation / Correction by a qualified contractor is recommended for all windows throughout the entire home.

Broken vacumm seals

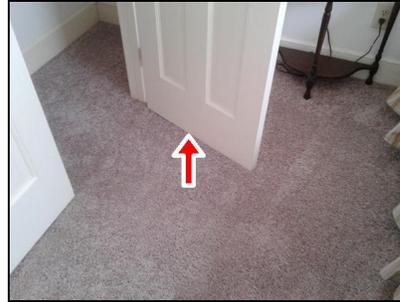
Second floor rear bedroom

Observed several interior doors that drag the carpet. (See photos for locations) This can cause further damage to finished flooring materials. Evaluation / Correction by a qualified handyman contractor is recommended for this entire condition.

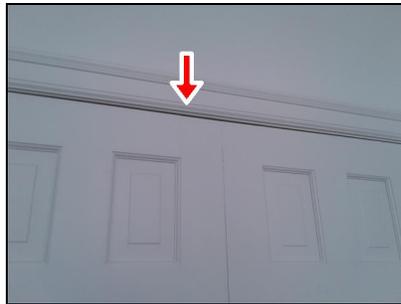
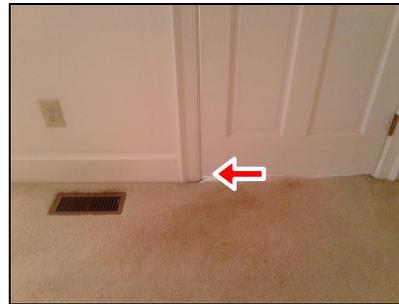
Observed that several of the room and closet doors hit and rub the door frames (See photos for locations) This is typically due to expansion and contraction from seasonal interior humidity. (Recommend checking all in all locations) Evaluation / Correction by a qualified handyman contractor is recommended for this entire condition.

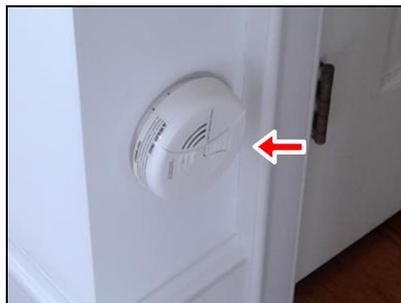
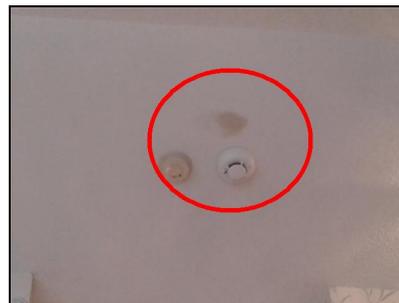
Observed that none of the smoke / carbon monoxide detectors responded to testing. Replacement of units or batteries is recommended. Smoke / fire detection systems and fire extinguishers are generally recommended for all homes. Any installed systems should be checked / serviced at least monthly. Conditions are conducive to safety concerns. Evaluation / Correction by a qualified contractor is recommended for this entire condition.

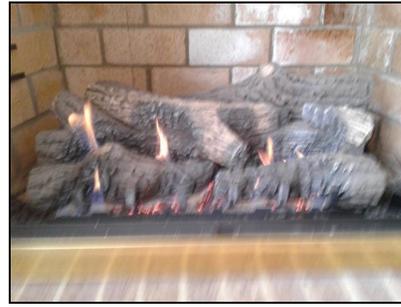
Observed that the fireplace damper door does not have a safety clamp installed. The safety clamp will not allow the damper door to be closed completely. This is a safety concern due too fireplaces having gas logs installed. It was not possible determined if this gas logs were the non-vented type. Condition is conducive to a potential safety hazard. Evaluation / Correction by a qualified fireplace contractor is recommended for this entire condition.

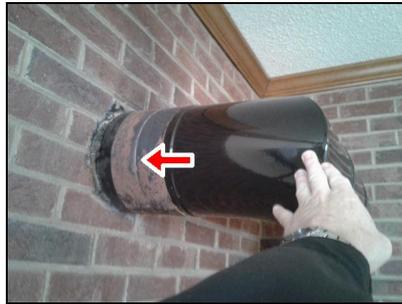
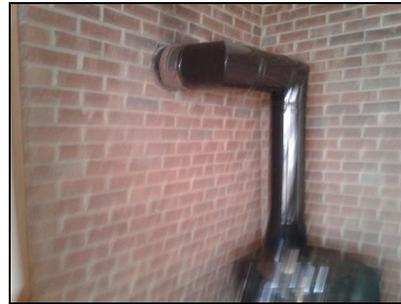
Observed that the wood stove pipe in the basement was very loose where it passes through the wall. Condition is conducive to a potential safety hazard. Evaluation / Correction by a qualified fireplace contractor is recommended for this entire condition.

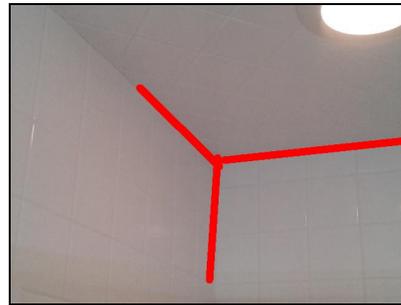
Master bath shower

Observed openings in the grout lines around the base of the master bath shower. Tile shower floors that were installed when this home was built are prone to leaking and failure. Condition is conducive to other potential damages. Evaluation / Correction by a qualified general / tile contractor is recommended for this entire condition.

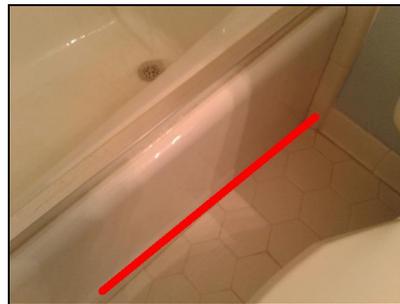
Second floor hall bath

Observed that the flooring at the base of the hall tub needs to be sealed to prevent water penetrations. Condition is conducive to damaged subflooring materials. Evaluation / Correction by a qualified handyman contractor is recommended for this entire condition.

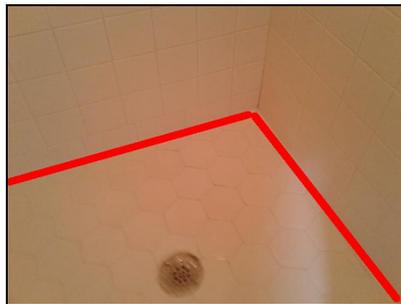
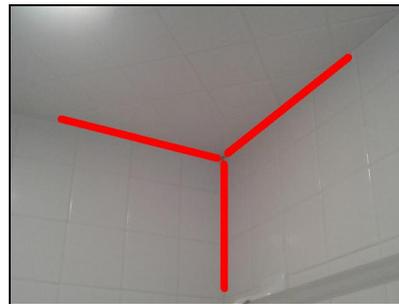
Observed openings in the grout lines around the base of the first floor bath shower. Tile shower floors that were installed when this home was built are prone to leaking and failure. Condition is conducive to other potential damages. Evaluation / Correction by a qualified general / tile contractor is recommended for this entire condition.

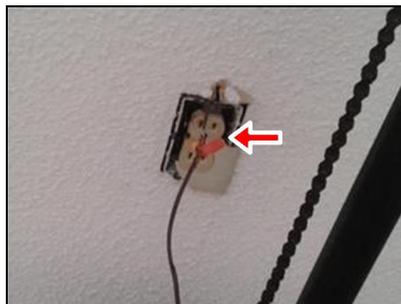
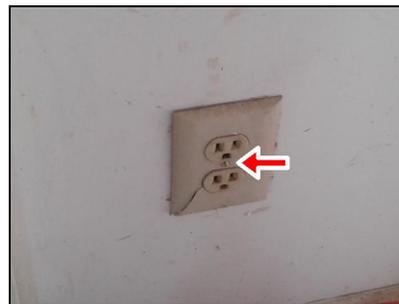
Observed several missing / broken outlet / switch covers in multiple locations (See photos for locations). Condition is conducive to a safety hazard. Evaluation / Correction by a qualified handyman contractor is recommended for this entire condition.

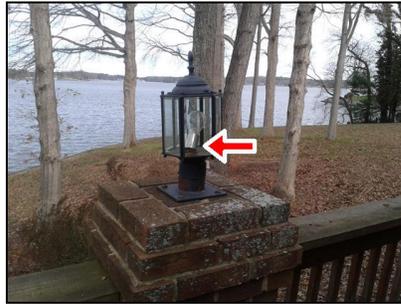
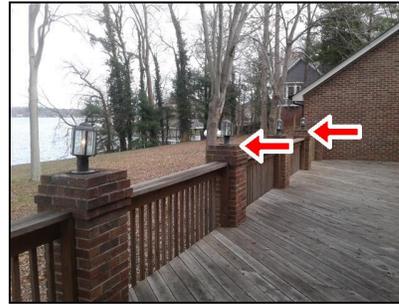
Observed that several lights in various locations did not function (See photos for locations). Recommend bulb replacement to ensure proper function first. If not bulb then Evaluation / Correction by a qualified electrical contractor may be necessary.

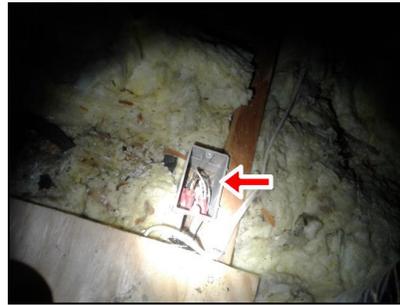
**Main attic**

Observed improperly terminated wiring in the attic (See photos for locations). These wires need to be properly installed inside a junction box and covered. Condition is conducive to a potential safety hazard. Evaluation / Correction by a qualified electrical contractor is recommended for this entire condition.

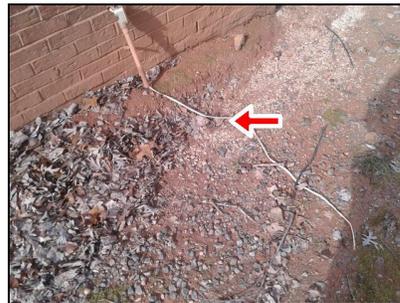
**Right side of garage**

Observed a romex electrical wire that was run outside the wall located at the right side of the garage. This type of wire either needs to be installed inside the wall or covered with a protective conduit. Condition is conducive to potential safety hazards. Evaluation / Correction by a qualified electrical contractor is recommended for this entire condition.

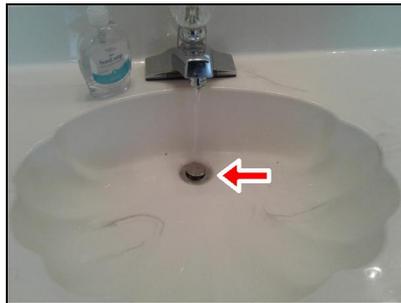
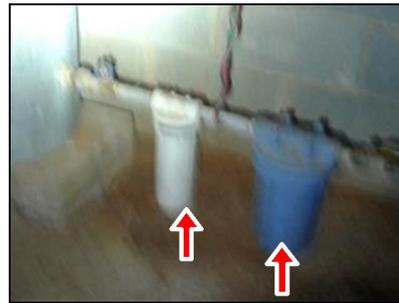
Observed an odor and dirty water coming out of the plumbing system and water heater. This indicates sulfur and or some other form of bacteria is inside the water heater. Condition is conducive to further damages. Evaluation / Correction by a qualified plumbing contractor is recommended for the entire plumbing system followed up by a water quality test.

Stained water

Water filters

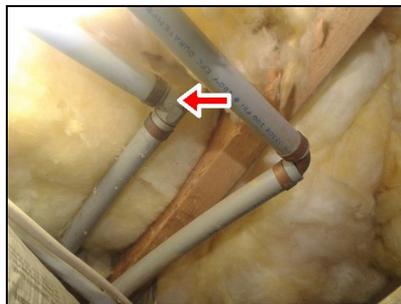
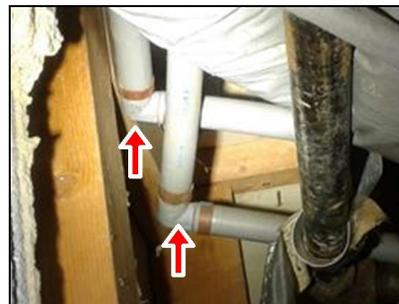
Observed some polybutylene pipe fittings under the crawl space. The North Carolina Home Inspection Licensure Board officially recommends that the home inspector identify the potential concerns with polybutylene plumbing pipe. Polybutylene has been used for many years, but has had a higher than normal failure rate. Copper and Brass fittings used in later years have apparently reduced the failure rate. Condition is conducive to other potential damages. Evaluation / Correction by a qualified plumbing contractor is recommended for this entire condition.

Polybutylene pipe fittings

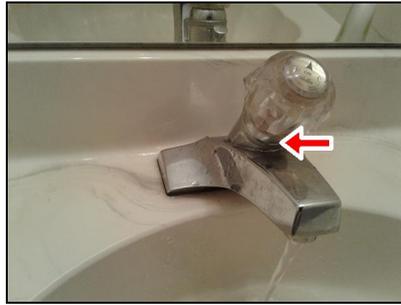
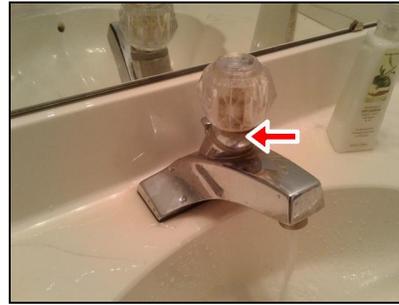
Observed that water leaks out from under the first and second floor hall bath sink faucet handles when turned on. This is generally an indication that the rubber seals inside need to be replaced. Evaluation / Correction by a qualified plumbing contractor is recommended for this entire condition.

First floor hall bath

Second floor hall bath

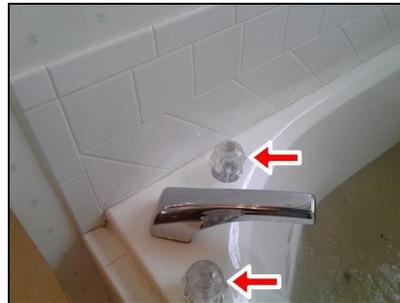
Master bath tub

Observed that water leaks out from under the master bath tub faucet handle when turned on. This is generally an indication that the rubber seals inside need to be replaced. Evaluation / Correction by a qualified plumbing contractor is recommended for this entire condition.

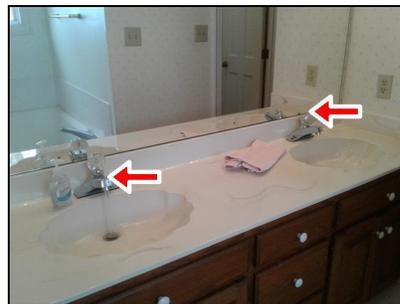
Master bath faucets

Observed that water leaks out from under the master bath sink faucet handle when turned on. This is generally an indication that the rubber seals inside need to be replaced. Evaluation / Correction by a qualified plumbing contractor is recommended for this entire condition.

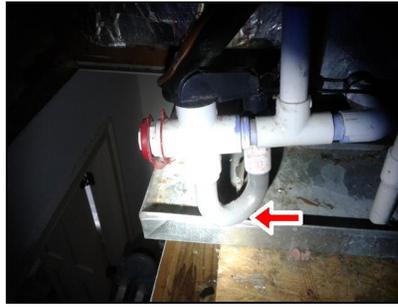
Second floor condensation  
drain

Observed that the condensation drain line for the second floor air handler. Condition is conducive to condensation water back up and other potential damages. Evaluation / Correction by a qualified HVAC contractor is recommended for this entire condition.

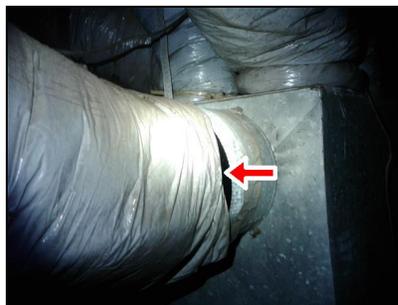
Crawl space air handler unit

Observed air leakage at the crawl space air handler unit supply plenum. All joints / duct connections and other possible areas of air leakage need to be properly sealed. Taped joints that are not mastic sealed are prone to failure and leakage. Evaluation / Correction by a qualified HVAC contractor is recommended for this entire condition.

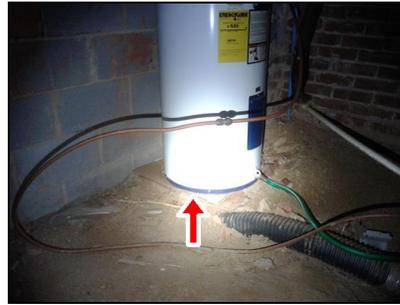
**Water heater**

Observed that the water heater is sitting in the dirt under the crawl space. This will promote rusting at the bottom of the water heater. Condition is conducive to further damages. Evaluation / Correction by a qualified plumbing contractor is recommended for this entire condition.

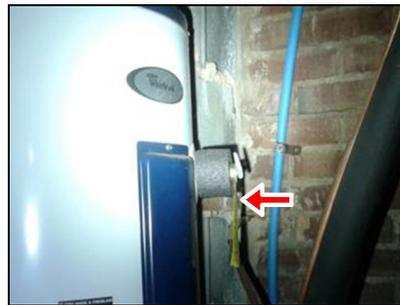
**TRP valve**

Observed that a 3/4 inch drain tube for the TPRV valve should be run from the water heater to the exterior. Condition is conducive to water penetrations in the crawl space. Evaluation / Correction by a qualified plumbing contractor is recommended for this entire condition.

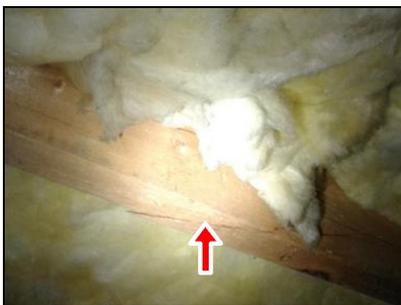
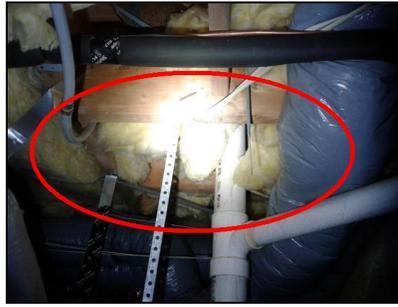
Observed damaged and cut floor joists under the laundry room / master bath and hall bath areas. A floor joist under the master bath area has been cut through allowing extra stress to the adjacent floor joists and causing them to sag and crack. Condition is conducive to further damages. Evaluation / Correction by a qualified general contractor is recommended for this entire condition.

**Broken floor joists**

Cut floor joist

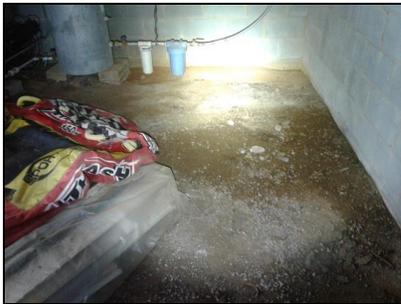
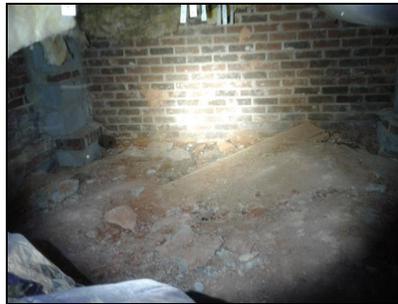
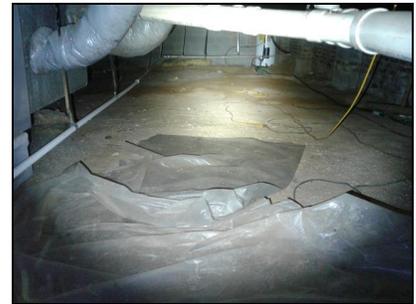
Observed no moisture barrier in the crawl space. Moisture barriers keep under ground moisture from entering the crawl space area. Condition is conducive to high moisture content, which in turn is conducive to wood destroying insects / fungi growth and other potential concerns. It is highly recommend that a 6 mil ploy plastic be installed and covering 100% of the dirt area. Evaluation / Correction by a qualified contractor is recommended for this entire condition.

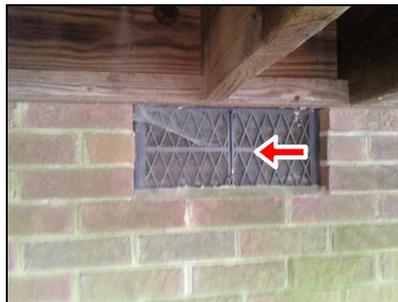
Observed that some of the foundation vents were found closed. This condition restricts proper air flow and cross ventilation for crawlspace. Recommend keeping open all foundation vents open all year round to allow for proper cross ventilation. Foundation vents that are broken / missing need to be repaired / replaced. Vents that are below grade need to have vent wells installed.

Foundation vents closed

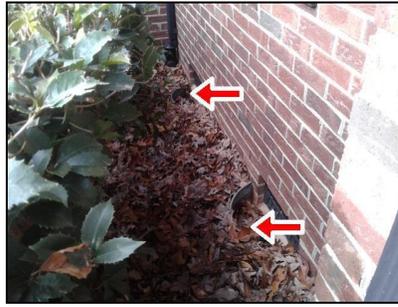
Observed that most of the crawls space vents are clanged with leaf debris. This condition restricts proper air flow and cross ventilation for crawlspace. Recommend keeping open all foundation vents open all year round to allow for proper cross ventilation. Foundation vents that are broken / missing need to be repaired / replaced. Vents that are below grade need to have vent wells installed.

Foundation vents clogged

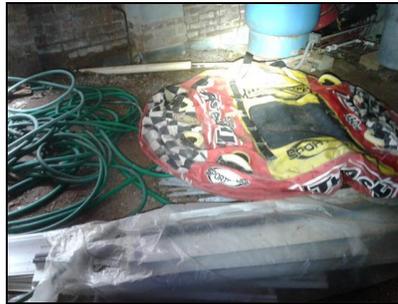
**Observed wood debris and other trash items in the crawl space. All wood, trash or cardboard debris must be kept out of crawl space areas. Condition is conducive to wood destroying insects and other potential concerns.**

Trash on soil

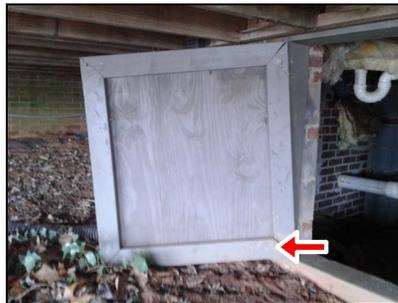
**Observed that the right side crawl space door was broken off its hinges. Condition is conducive to further damages. Evaluation / Correction by a qualified handyman contractor is recommended for this entire condition.**

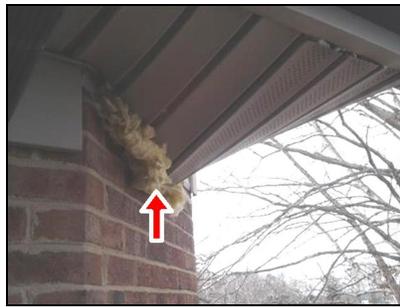
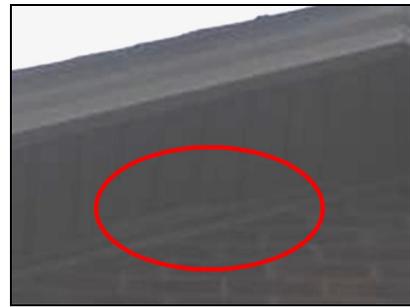
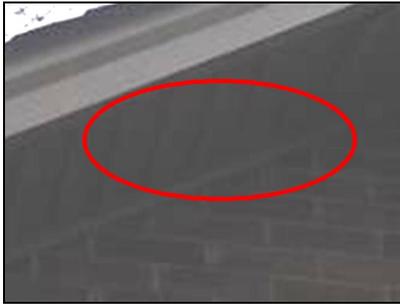
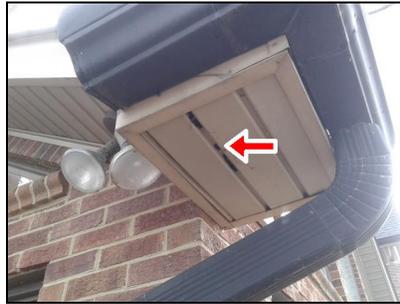
**1.1** Observed that the vinyl soffit is loose / pushed up / damaged in several location. Most of this damage is due too recent rodent penetrations at the upper attic areas (See exterior section of this report for further comments) Condition is conducive to other damages. Evaluation / Correction by a qualified contractor is recommended for this entire condition.

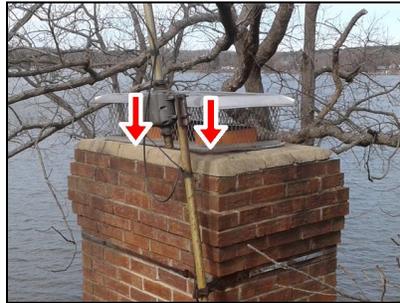
Top of chimney

**1.3** Observed cracked areas of the chimney mortar cap and open areas between cap and flue liner. Conditions are conducive to water penetrations at interior of chimney / fireplace. Seal with proper material to avoid water penetrations. Evaluation / Correction by a qualified chimney contractor is recommended for this entire condition.

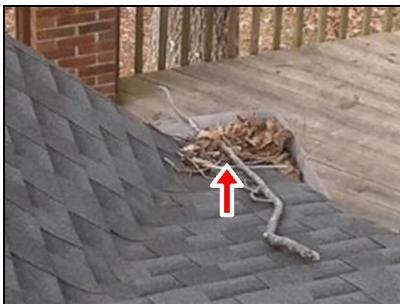
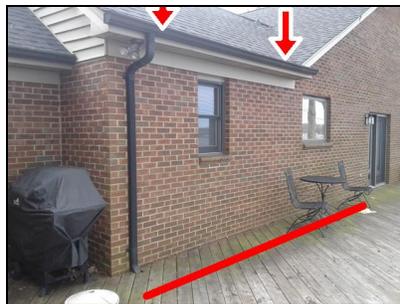
**1.5** Observed multiple gutters filled with debris, keep clean for proper function. All gutters should be checked for damage, blockage, or overflow on a regular basis (at least twice annually). Gutter guards may help in cases where leaves and other debris routinely accumulate in a short period of time. Condition is conducive to further damages. Evaluation / Correction by a qualified handyman contractor is recommended for this entire condition.

Debris and gutters

Gutters overflowing right rear

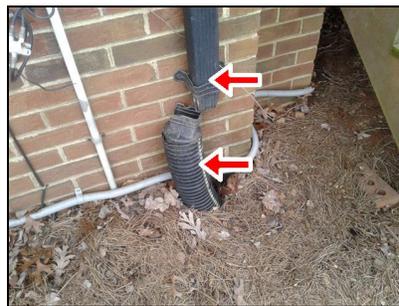
**1.6** Observed downspouts terminating at the foundation wall and missing diverter / splash block / leader pipes in various locations (See Photos). Providing an adequate roof drainage system, diverting all downspouts away from the foundation and providing adequate soil grading and ground cover at the foundation and throughout the site are primary remedial factors to consider for any water penetration concerns. Downspouts that run into the ground are subject to backup / blockage. Neither the presence nor integrity of underground lines, nor free flow of water through such lines is determinable as part of this inspection. Condition is conducive to water penetrations into crawl space and other areas. Evaluation / Correction by a qualified handyman contractor is recommended for this entire condition.

Downspouts disconnected

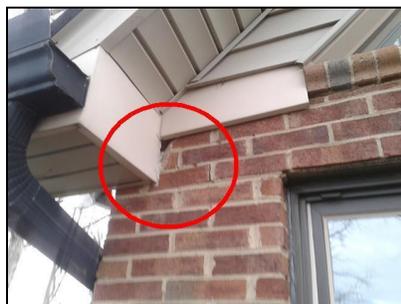
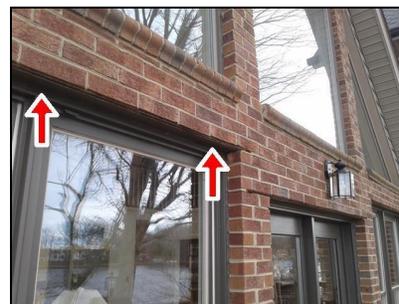
Rear family room wall

**2.0** Observed cracking and separation in the brick mortar joints where the brick sits on top of the window lintils at the rear family room wall. This is an indication of some previous movement due to potential water penetrations. (See interior section of this report for further comments) Further / Investigation / Evaluation / Correction by a qualified contractor is recommended for this entire condition.

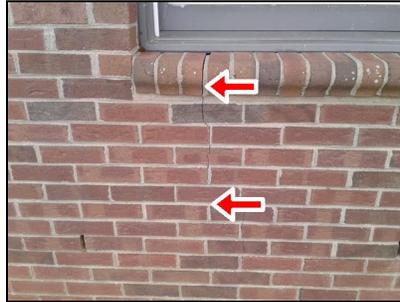
**2.0** Observed small cracks in the brick veneer at the rear garage wall . These are typical in nature due to age and normal masonry shrinkage. Although small cracks in brick veneers are typical, these areas should be resealed too prevent any water penetrations or damages. Evaluation / Correction by a qualified handyman contractor is recommended for this entire condition.

Small crack @ rear garage wall

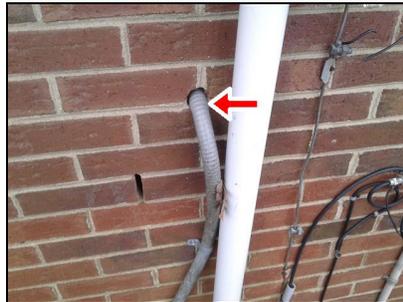
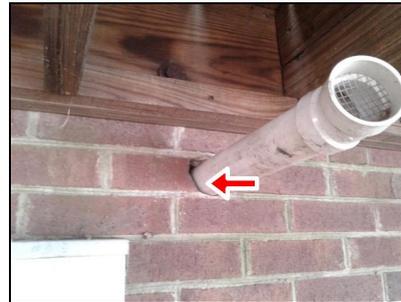
**2.0** Observed that caulk sealing is needed at all pipes / wires were they pass through the house wall (See photos for locations). Condition is conducive to potential water penetrations and other damage. Evaluation / Correction by a qualified handyman contractor is recommended for this entire condition.

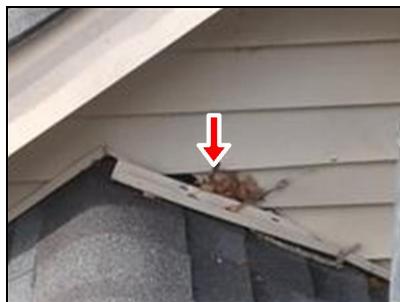
Above garage entry roof

**2.1** Observed holes and damaged areas of siding and trim at various locations (See photos for locations). Areas that were observed are from ground level (only) but there may be additional repairs needed higher up and / or out of view. Condition is conducive to potential water penetrations. Evaluation / Correction by a qualified handyman contractor is recommended for this entire condition.

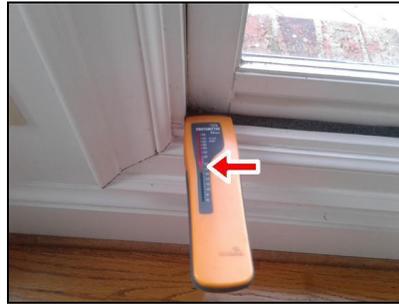
**2.3** Observed wood rot / decay / damage and deterioration at multiple window frames around the home. Condition is conducive to further damages. Evaluation / Correction by a qualified general contractor is recommended for this entire condition.

High moisture breakfast room window frames

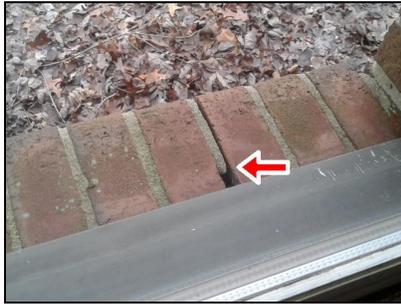
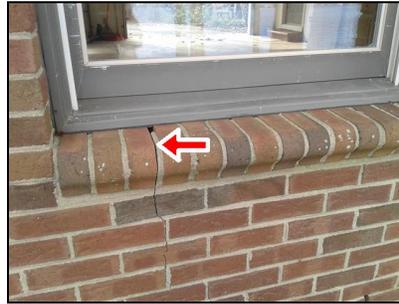
Back wall of garage

**2.3** Observed that the caulk sealing needs to be re-done at all windows and exterior doors where the brick meets the window and door frames. Condition is conducive to potential water penetrations. Evaluation / Correction by a qualified handyman contractor is recommended for this entire condition.

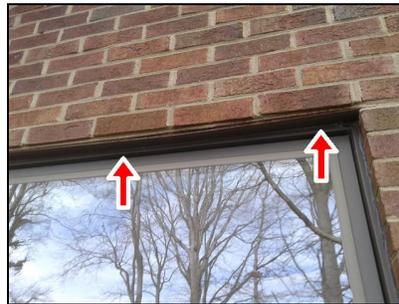
All exterior windows

**2.3** Observed that all steel lintels over exterior windows and doors need to be rust proof painted. Condition conducive to rusting which in turn will expand the steel and cause mortar joint cracking. Evaluation / Correction by a qualified handyman contractor is recommended for this entire condition.

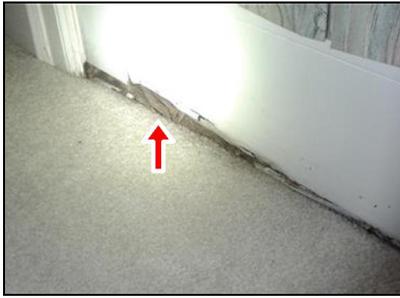
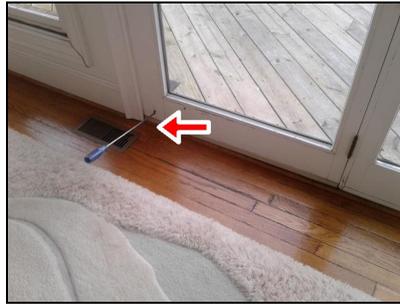
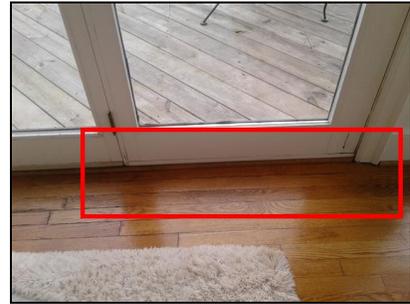
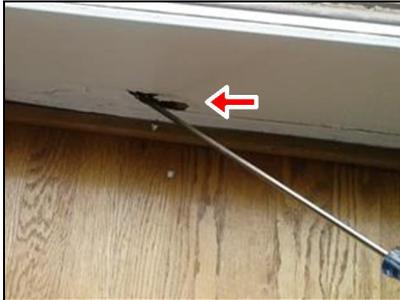
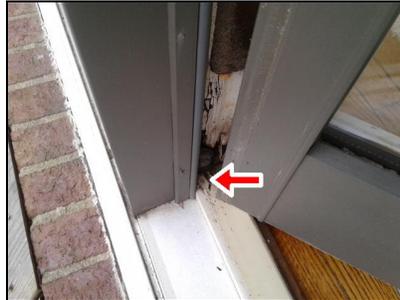
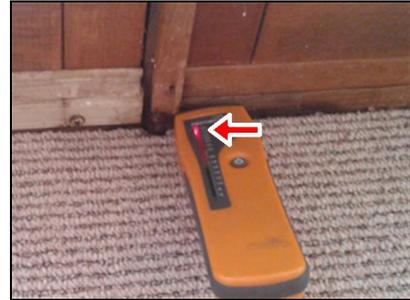
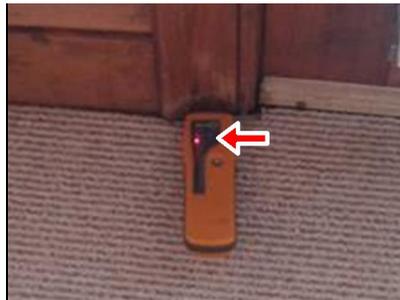
**2.4** Observed wood rot / decay at several exterior door panels and frames (See photos for locations). The damage to the master bedroom / family room / breakfast room door panels is severe enough to warrant replacement. This is typically due too and a common problem with poor maintenance of the caulk joints at these locations. Condition is conducive to further damages. Evaluation / Correction by a qualified general contractor is recommended for this entire condition.

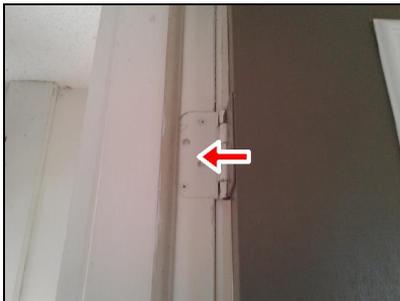
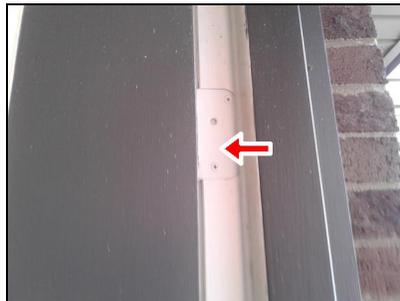
**2.4** Observed missing hinges screws at several exterior doors (See photos for locations) Condition is conducive to door sagging, rubbing over a period of time. Evaluation / Correction by a qualified handyman contractor is recommended for this entire condition.

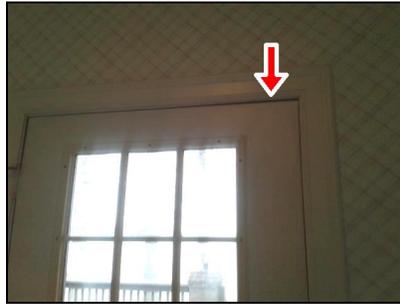
Rear door

**2.4** Observed that the rear door rubs / hits the frame. Condition is conducive to further damages. Evaluation / Correction by a qualified handyman contractor is recommended for this entire condition.

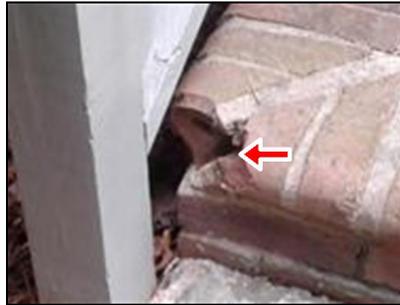
Front stairs

**2.5** Observed open mortar joints and loose bricks at the front steps in several locations. All open mortar joints need to be sealed to prevent water penetrations. Condition is conducive to further damages. Evaluation / Correction by a qualified handyman contractor is recommended for this entire condition.
