**James Jones**

**123 Second Street  
USA**

May 06, 2020

## General Summary

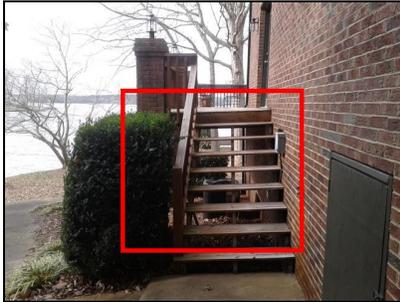
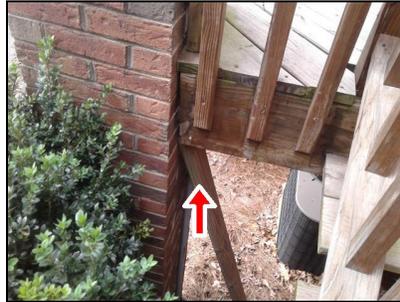
Left side of deck

**2.6** Observed that the left side of the deck and stairs have dropped slightly. The frame has also come loose from the first brick column. It appears that the brick columns itself has settled slightly over a period of time causing this damage. Further / Evaluation / Correction by a qualified general contractor is recommended for this entire condition.

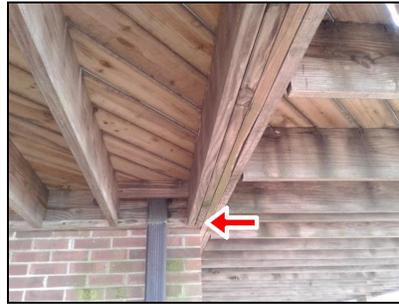
Support girder beam

**2.6** Observed a support girder beam at the right rear corner of the deck where the floor joists change direction. The beam is pulling loose from the house wall and has dropped slightly. The support connection to the house wall is not adequate which has caused this settlement. Condition is conducive to further movement. Evaluation / Correction by a qualified general contractor is recommended for this entire condition.

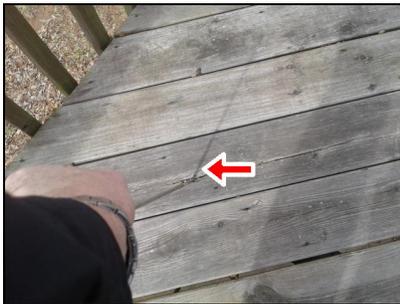
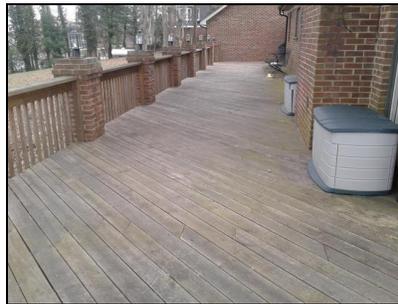
Main deck surface

**2.6** Observed decking and railings to have cracked / deteriorated materials in various areas and some nails are backing out. Repair / replace cracked and deteriorated materials as needed and for weathered deck surfaces we recommend sealing wood as needed and resetting nails. Condition is conducive to further damages. Evaluation / Correction by a qualified general / handyman contractor is recommended for this entire deck / condition.

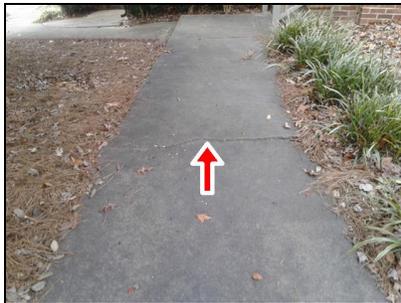
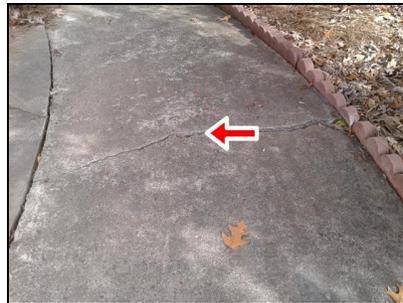
**3.0** Observed sections of the concrete walkways that are raised up. Although concrete movement and typical cracking is common in almost every home this condition poses a safety (tripping) hazard. Evaluation / Correction by a qualified contractor is recommended for this entire condition.

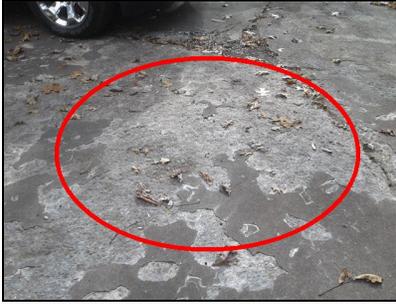
Driveway

**3.1** Observed sections of the driveway that are raised up with some displacement. Although concrete movement and typical cracking is common in almost every home this condition poses a safety (tripping) hazard. Evaluation / Correction by a qualified general / concrete contractor is recommended for this entire condition.

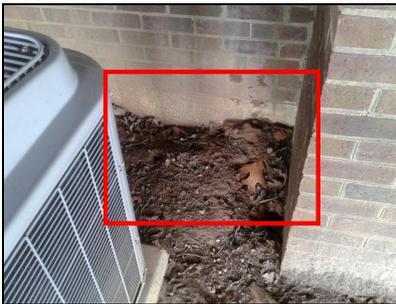
Right rear

**3.2** Observed a negative / flat grade slope toward the right rear corner of the foundation. This could allow water runoff and ponding which could lead to water penetrations into the crawl space and other concerns. Suitable drainage conditions need to be maintained and in order to prevent any future problems. Evaluation / Correction by a qualified handyman contractor is recommended for this entire condition.

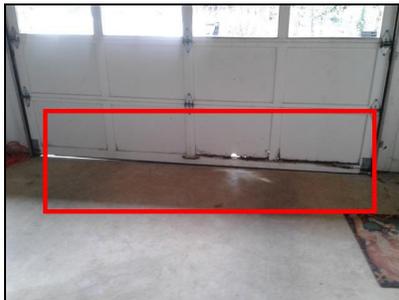
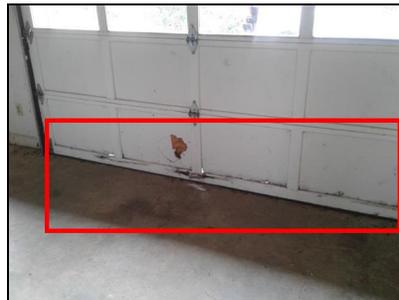
Bottom of garage doors

**4.2** Observed that all three of the garage doors at wood rot / and moisture damages at the bottom panels and other various locations. Condition is conducive to further damages. Evaluation / Correction by a qualified garage door contractor is recommended for this entire condition.

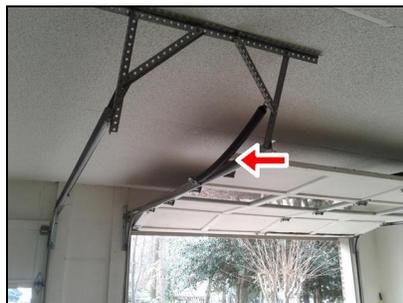
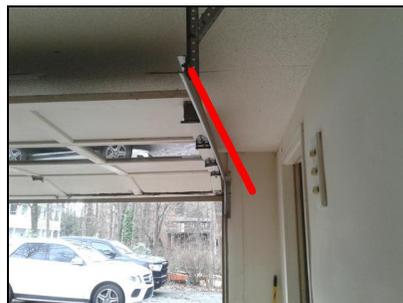
GD 3 springs

**4.2** Observed that the garage door that is closest to the house entrance is missing the door springs. Condition is conducive to further damages. Evaluation / Correction by a qualified garage door contractor is recommended for this entire condition.

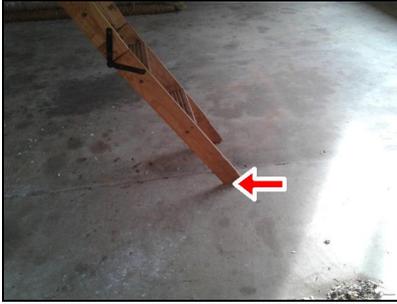
Garage attic stairs

**5.4** Observed that the garage attic stair unit steps needs to be cut off so the ladder is on the a flat plane. This condition is conducive to stressing the ladder joints. Evaluation / Correction by a qualified handyman contractor is recommended for this entire condition.

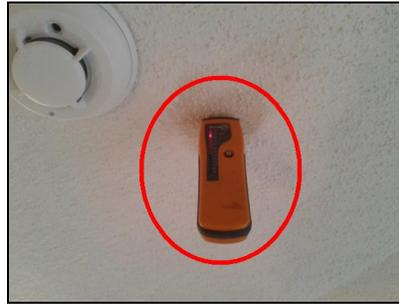
Second floor ceiling

**6.0** Observed previous water staining at the second floor hall ceiling which was due to a previous roofing leak. Moisture tests were performed at all locations with positive results. Condition is conducive to further damages. Evaluation / Correction by a qualified contractor is recommended for this entire condition.

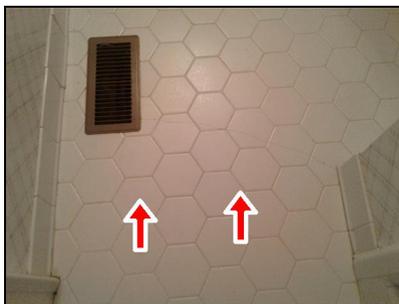
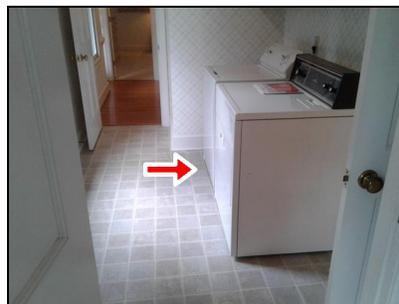
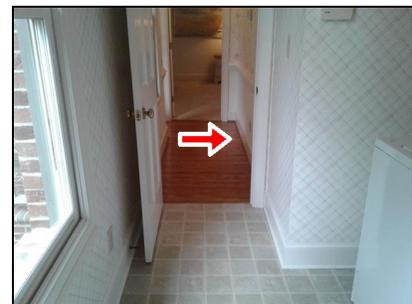
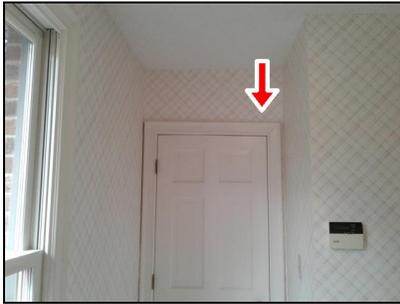
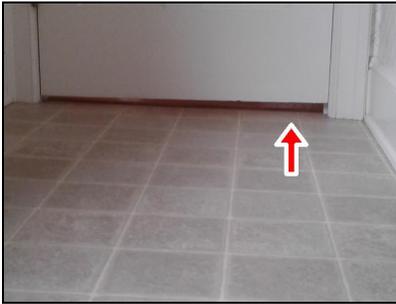
**6.2** Observed evidence of previous movement in the floor that is under the laundry room / first floor bath / and master bedroom. The substructure / floor joists under this area were viewed with some damage. (See foundation section for further comments) Further Evaluation / Correction by a qualified contractor is recommended for this entire condition.

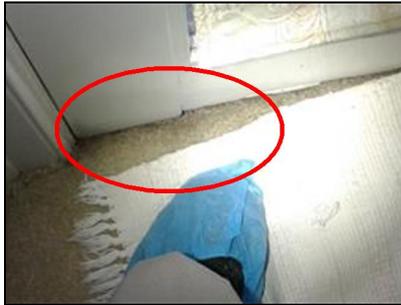
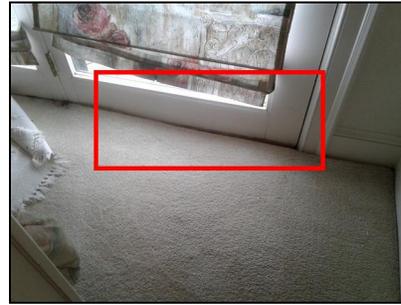
Master bedroom floor

**6.2** Observed water damages at the master bedroom subflooring at the exterior door. This is due to water penetrations into the door frame and under the sill plate. Condition is conducive to further damages. Evaluation / Correction by a qualified general contractor is recommended for this entire condition.

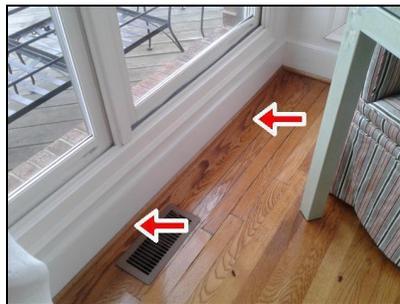
Family room

**6.2** Observed water damaged wood flooring at the family room wall. See Interior Wall section of this report for further comments.

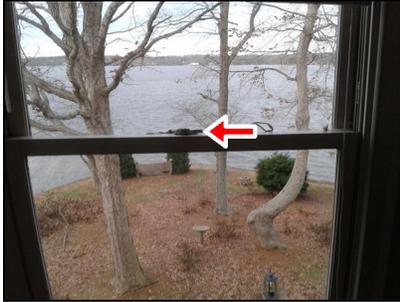
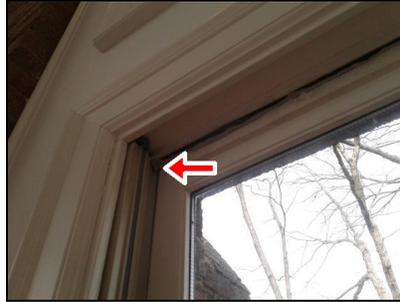
**6.5** Observed multiple windows throughout the home that do not functioning as intended and are most likely painted shut / have broken spring balances or hardware that is difficult to operate. This condition is a concern in regards to safety conditions and egress in case an emergency exit is needed. (Recommend checking all in all locations). Evaluation / Correction by a qualified general contractor is recommended for this entire condition.

Check all windows

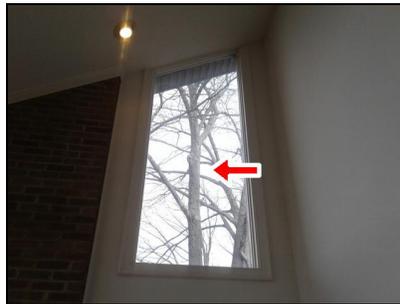
**6.5** Observed broken vacuum seals at several windows (See photos for locations) Replacement of insulated glass windows or doors is usually required to correct failed vacuum seals. Evaluation / Correction by a qualified contractor is recommended for all windows throughout the entire home.

Broken vacuum seals

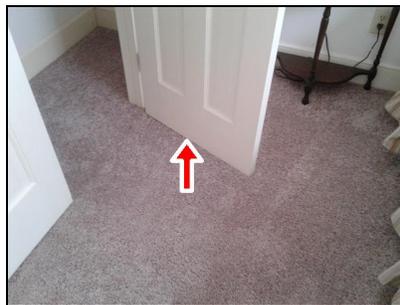
Second floor rear bedroom

**6.6** Observed several interior doors that drag the carpet. (See photos for locations) This can cause further damage to finished flooring materials. Evaluation / Correction by a qualified handyman contractor is recommended for this entire condition.

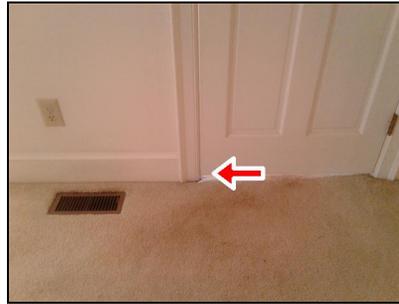
Master bedroom

**6.6** Observed that several of the room and closet doors hit and rub the door frames (See photos for locations) This is typically due to expansion and contraction from seasonal interior humidity. (Recommend checking all in all locations) Evaluation / Correction by a qualified handyman contractor is recommended for this entire condition.

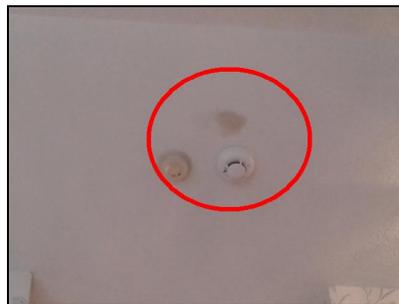
Second floor

**6.7** Observed that none of the smoke / carbon monoxide detectors responded to testing. Replacement of units or batteries is recommended. Smoke / fire detection systems and fire extinguishers are generally recommended for all homes. Any installed systems should be checked / serviced at least monthly. Conditions are conducive to safety concerns. Evaluation / Correction by a qualified contractor is recommended for this entire condition.

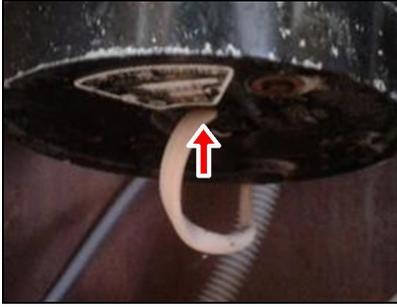
**7.6** Observed improperly terminated wiring at the garbage disposal. A box connector or rubber gromet needs to be installed to prevent the wires from being damaged from vibration. Evaluation / Correction by a qualified electrical contractor is recommended for this entire condition.

Disposal wiring

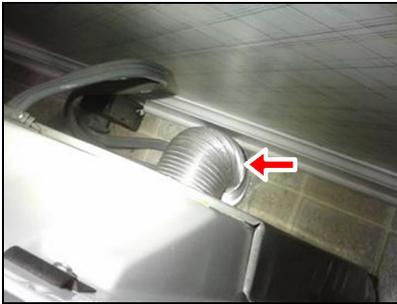
**7.8** Due to construction / storage items and or lack of visibility, determination of lint inside the dryer vent piping was not possible to see. All dryer vents need to be checked / serviced annually. Conditions are conducive to potential safety hazards.

Dryer vent connected

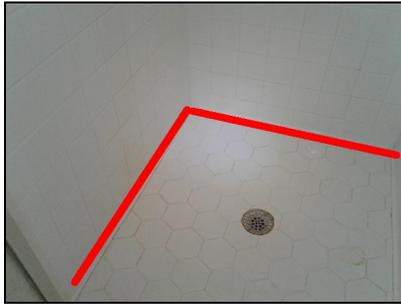
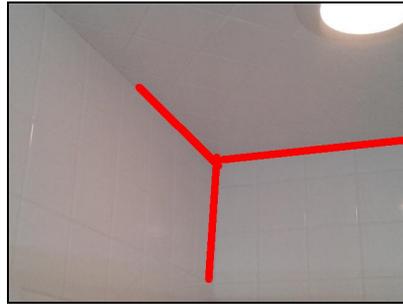
Master bath shower

**8.4.A** Observed openings in the grout lines around the base of the master bath shower. Tile shower floors that were installed when this home was built are prone to leaking and failure. Condition is conducive to other potential damages. Evaluation / Correction by a qualified general / tile contractor is recommended for this entire condition.

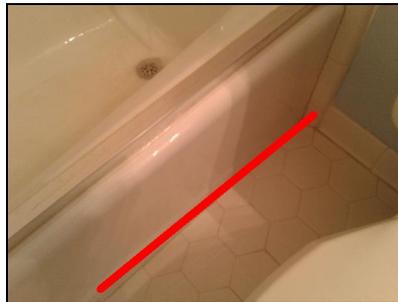
Second floor hall bath

**8.6.B** Observed that the flooring at the base of the hall tub needs to be sealed to prevent water penetrations. Condition is conducive to damaged subflooring materials. Evaluation / Correction by a qualified handyman contractor is recommended for this entire condition.

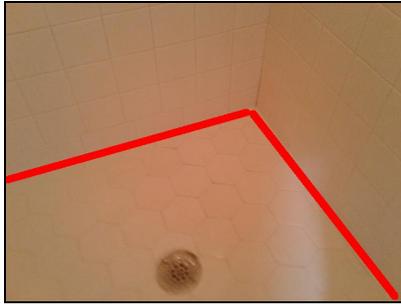
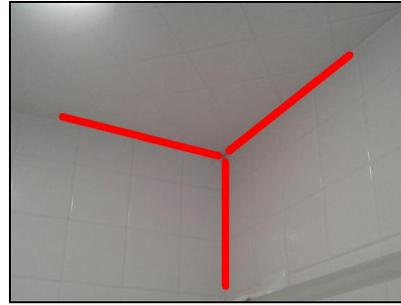
First floor bath shower

**8.3.C** Observed openings in the grout lines around the base of the first floor bath shower. Tile shower floors that were installed when this home was built are prone to leaking and failure. Condition is conducive to other potential damages. Evaluation / Correction by a qualified general / tile contractor is recommended for this entire condition.

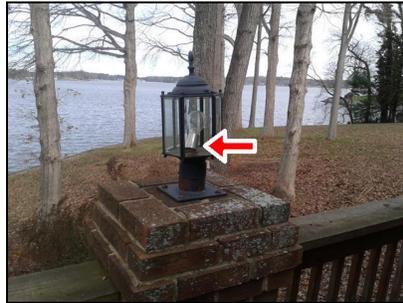
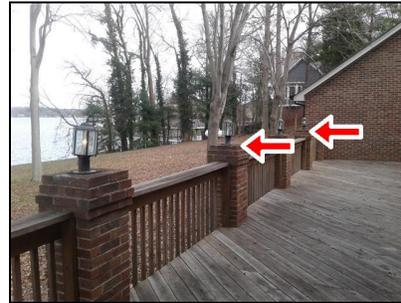
**9.4** Observed that several lights in various locations did not function (See photos for locations). Recommend bulb replacement to ensure proper function first. If not bulb then Evaluation / Correction by a qualified electrical contractor may be necessary.

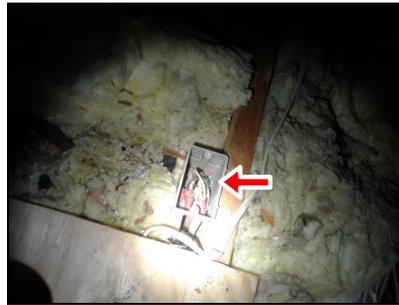
Main attic

**9.5** Observed improperly terminated wiring in the attic (See photos for locations). These wires need to be properly installed inside a junction box and covered. Condition is conducive to a potential safety hazard. Evaluation / Correction by a qualified electrical contractor is recommended for this entire condition.

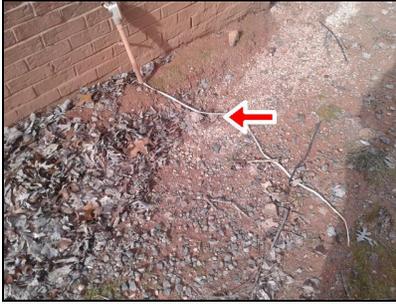
Right side of garage

**9.5** Observed a romex electrical wire that was run outside the wall located at the right side of the garage. This type of wire either needs to be installed inside the wall or covered with a protective conduit. Condition is conducive to potential safety hazards. Evaluation / Correction by a qualified electrical contractor is recommended for this entire condition.

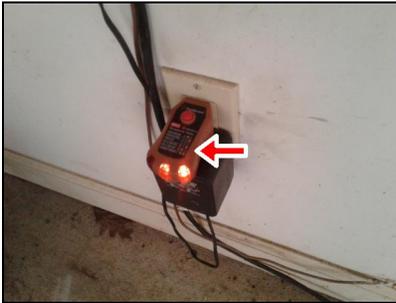
Back wall of garage

**9.6** Observed that the Ground-fault Circuit-interrupter at the back wall of the garage failed to operate properly when tested. This may indicate a wiring problem or a defect with the device. Condition is conducive to potential safety hazards. Evaluation / Correction by a qualified electrical contractor is recommended for this entire condition.

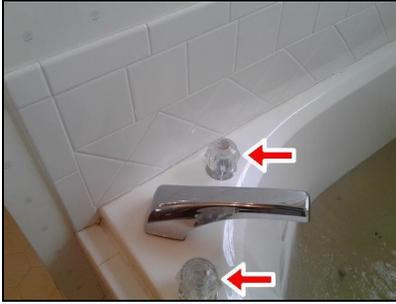
Master bath tub

**10.2** Observed that water leaks out from under the master bath tub faucet handle when turned on. This is generally an indication that the rubber seals inside need to be replaced. Evaluation / Correction by a qualified plumbing contractor is recommended for this entire condition.

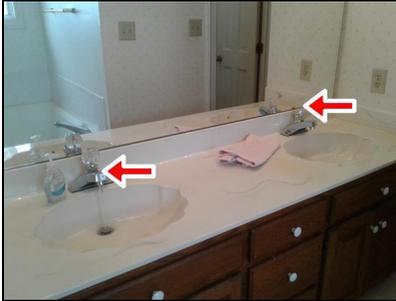
Master bath faucets

**10.2** Observed that water leaks out from under the master bath sink faucet handle when turned on. This is generally an indication that the rubber seals inside need to be replaced. Evaluation / Correction by a qualified plumbing contractor is recommended for this entire condition.

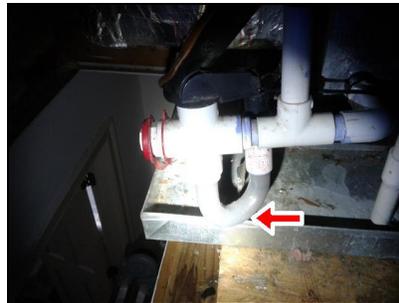
Second floor condensation drain

**11.2** Observed that the condensation drain line for the second floor air handler. Condition is conducive to condensation water back up and other potential damages. Evaluation / Correction by a qualified HVAC contractor is recommended for this entire condition.

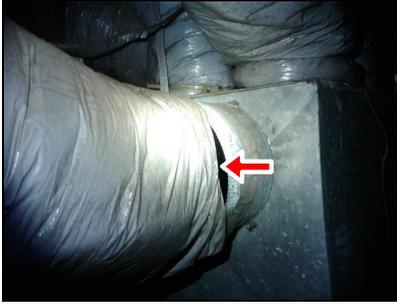
Crawl space air handler unit

**11.5** Observed air leakage at the crawl space air handler unit supply plenum. All joints / duct connections and other possible areas of air leakage need to be properly sealed. Taped joints that are not mastic sealed are prone to failure and leakage. Evaluation / Correction by a qualified HVAC contractor is recommended for this entire condition.

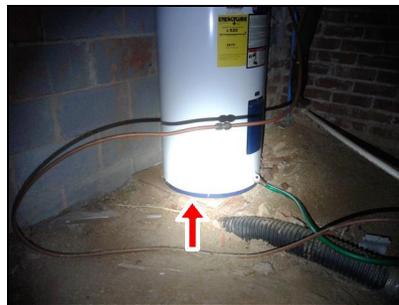
Water heater

**13.0** Observed that the water heater is sitting in the dirt under the crawl space. This will promote rusting at the bottom of the water heater. Condition is conducive to further damages. Evaluation / Correction by a qualified plumbing contractor is recommended for this entire condition.

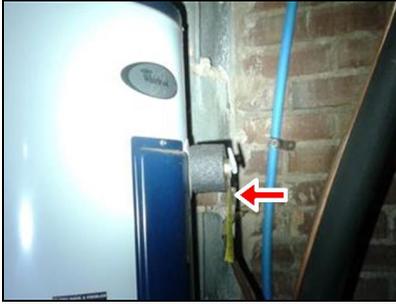
TRP valve

**13.3** Observed that a 3/4 inch drain tube for the TPRV valve should be run from the water heater to the exterior. Condition is conducive to water penetrations in the crawl space. Evaluation / Correction by a qualified plumbing contractor is recommended for this entire condition.

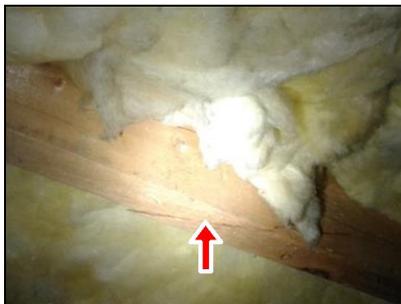
**14.2** Observed damaged and cut floor joists under the laundry room / master bath and hall bath areas. A floor joist under the master bath area has been cut through allowing extra stress to the adjacent floor joists and causing them to sag and crack. Condition is conducive to further damages. Evaluation / Correction by a qualified general contractor is recommended for this entire condition.

Broken floor joists

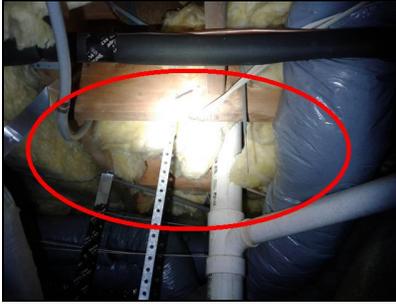
Cut floor joist

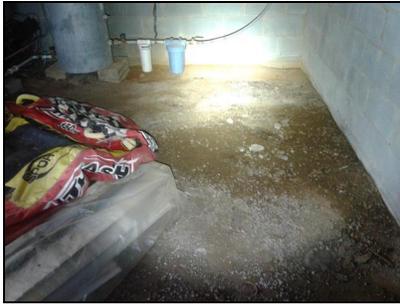
Left side CS

**14.4** Observed no moisture barrier in the crawl space. Moisture barriers keep under ground moisture from entering the crawl space area. Condition is conducive to high moisture content, which in turn is conducive to wood destroying insects / fungi growth and other potential concerns. It is highly recommend that a 6 mil ploy plastic be installed and covering 100% of the dirt area. Evaluation / Correction by a qualified contractor is recommended for this entire condition.

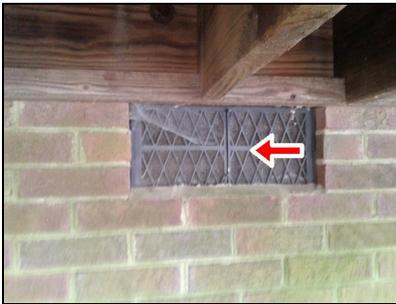
**14.5** Observed that some of the foundation vents were found closed. This condition restricts proper air flow and cross ventilation for crawlspace. Recommend keeping open all foundation vents open all year round to allow for proper cross ventilation. Foundation vents that are broken / missing need to be repaired / replaced. Vents that are below grade need to have vent wells installed.

Foundation vents closed

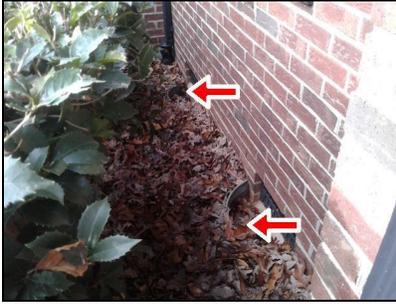
**14.5** Observed that most of the crawls space vents are clanged with leaf debris. This condition restricts proper air flow and cross ventilation for crawlspace. Recommend keeping open all foundation vents open all year round to allow for proper cross ventilation. Foundation vents that are broken / missing need to be repaired / replaced. Vents that are below grade need to have vent wells installed.

Foundation vents clogged

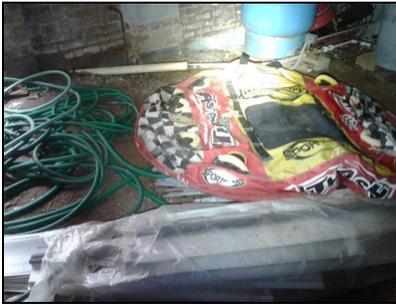
**14.6** Observed wood debris and other trash items in the crawl space. All wood, trash or cardboard debris must be kept out of crawl space areas. Condition is conducive to wood destroying insects and other potential concerns.

Trash on soil

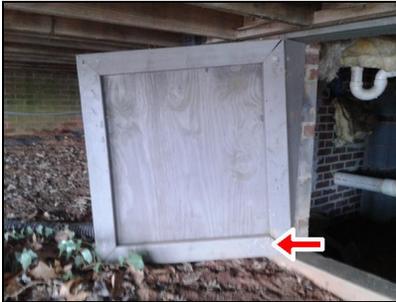
**14.6** Observed that the right side crawl space door was broken off its hinges. Condition is conducive to further damages. Evaluation / Correction by a qualified handyman contractor is recommended for this entire condition.
